# Stage 1 Road Safety Audit

Tallaght/Clondalkin to City Centre Core Bus Corridor  
BCIDA – ACM - STY\_ZZ – 0809\_XX\_00 – RP – ZZ – 0001

Client – National Transport Authority  
Stage – Stage 1

Date (March 2023)

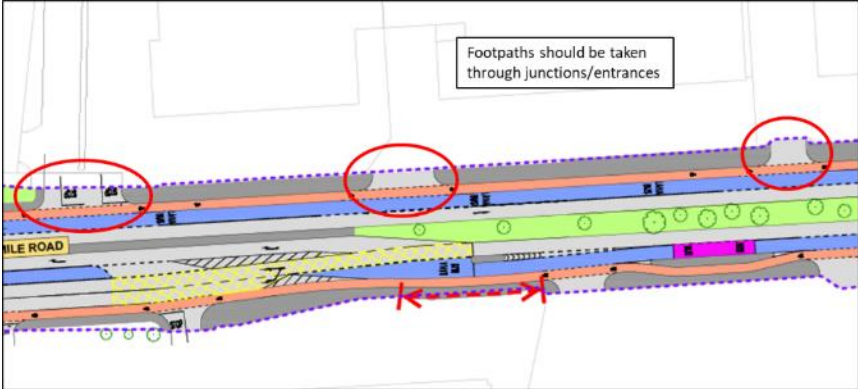
4.2.6 Problem	
<b>Location:</b>	Throughout the Scheme
<b>Summary:</b>	Discontinuation of footpath across junctions /entrances
<b>Description:</b>	
<p>The footpath has been discontinued at a number of junctions and accesses through the scheme. Failure to provide a footpath across the junctions/entrances would give motorists priority and therefore increase the risk of collisions with pedestrians. Figure below is an example of such a layout on Long Mile Road</p>

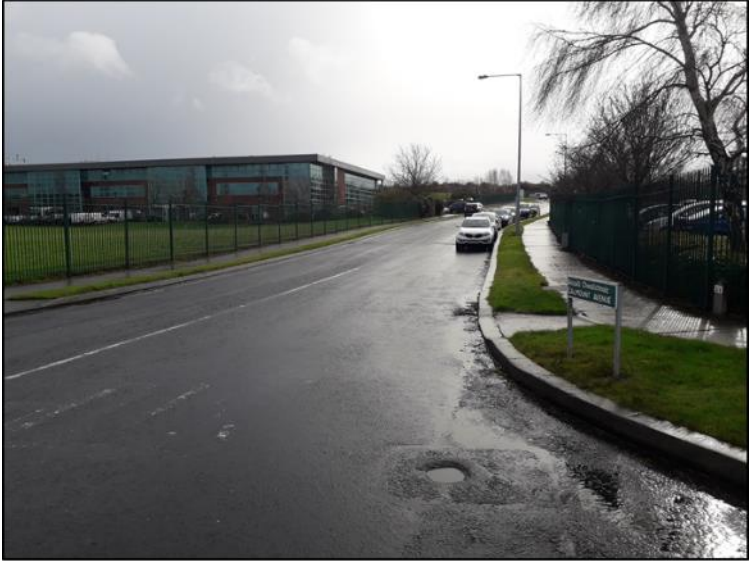
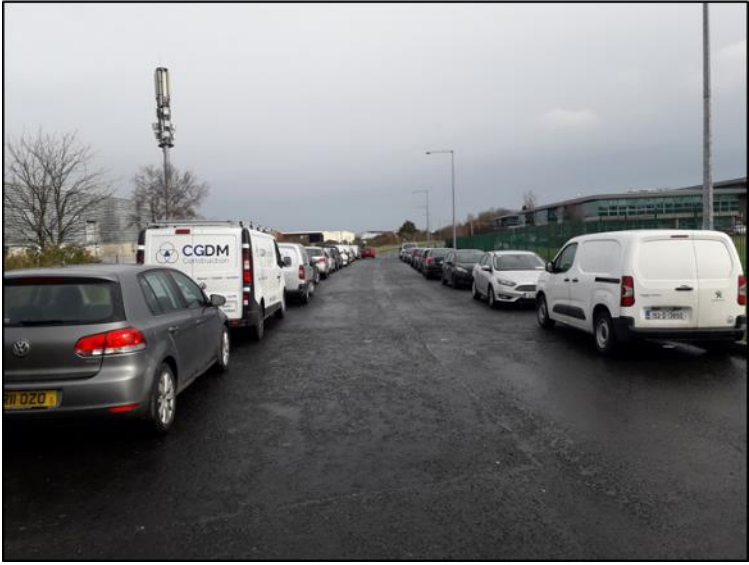
<b>4.3.13 Problem</b>

<i>Location:</i>	Calmount Road	
<i>Drawing:</i>	Sheet 16 of 47	
<i>Summary:</i>	On street parking will be displaced	
<p><b>Description:</b></p> <p>On-street parking along the existing Calmount Avenue was observed. There is a risk that motorists will continue to park on Calmount Avenue due to the shortfall in parking within the various adjacent commercial premises. The presence of parked vehicles on Calmount Avenue will obstruct the bus lane and result in buses having to suddenly divert onto the regular lane. This is likely to lead to collisions.</p>

<p><b>Recommendation:</b></p> <p>Enforcement measures should be implemented to discourage motorists from parking along Calmount Avenue.</p>

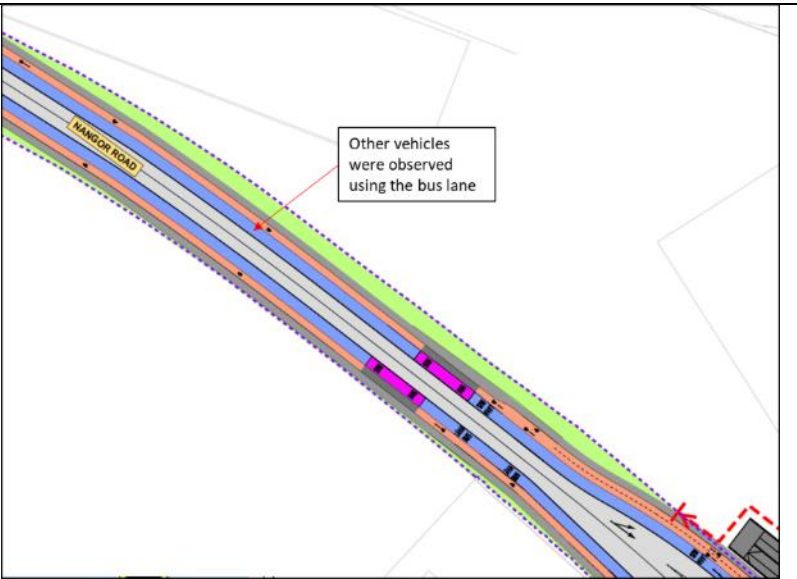
<b>4.3.11 Problem</b>

<p>Other vehicles were observed using the bus lane</p>
<b>Location:</b>	Nangor Road southeast bound bus lane	
<b>Drawing:</b>	Sheet 06 of 12	
<b>Summary:</b>	Vehicles observed using bus lane	
<b>Description:</b>		<p>It was observed during the site visit that motorists often used the southeast bound bus lane on Nangor Road. Given the long queues noted from the Long Mile Road junction, having additional traffic using the bus lane is likely to result in bus delays or possible collisions between buses and other vehicles.</p>
<b>Recommendation:</b>		<p>Enforcement measures should be implemented to discourage motorists from using the bus lane.</p>

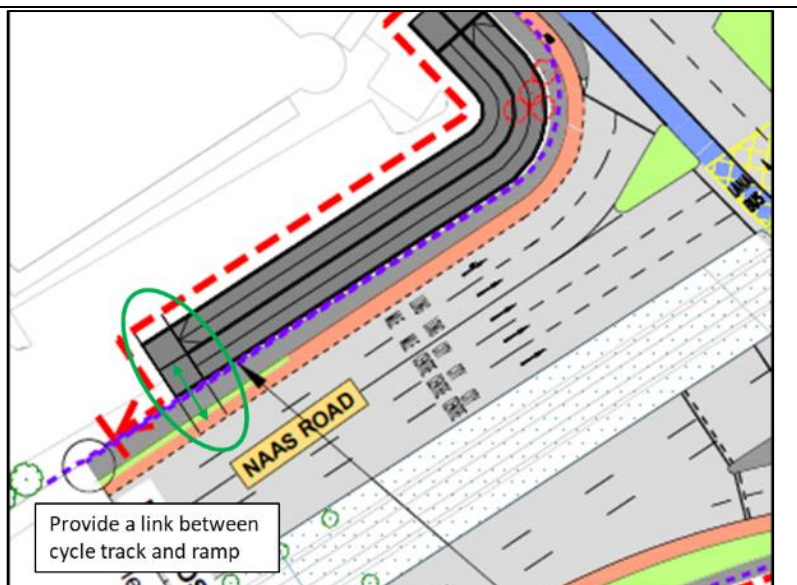
<b>4.3.14 Problem</b>

<p>Provide a link between cycle track and ramp</p>
<b>Location:</b>	At Nangor Road / Naas Road junction	
<b>Drawing:</b>	Sheet 07 of 12	
<b>Summary:</b>	Access to pedestrian and cycle bridge	
<b>Description:</b>		<p>It is not clear how cyclists on the eastbound cycle track on Naas Road will access the proposed pedestrian and cycle ramp. Failure to provide a safe link between the cycle track and ramp may result in cyclists having to dismount their bicycles in order to cross the grass verge and footpath or collisions between cyclists and pedestrians.</p> <p>If an easy access onto the ramp is not provided, some cyclists may decide to continue on the carriageway thus increasing the risk of collisions with motorists.</p>
<b>Recommendation:</b>		<p>Provide a safe link between the eastbound cycle track on Naas Road and proposed pedestrian/cycle ramp.</p>

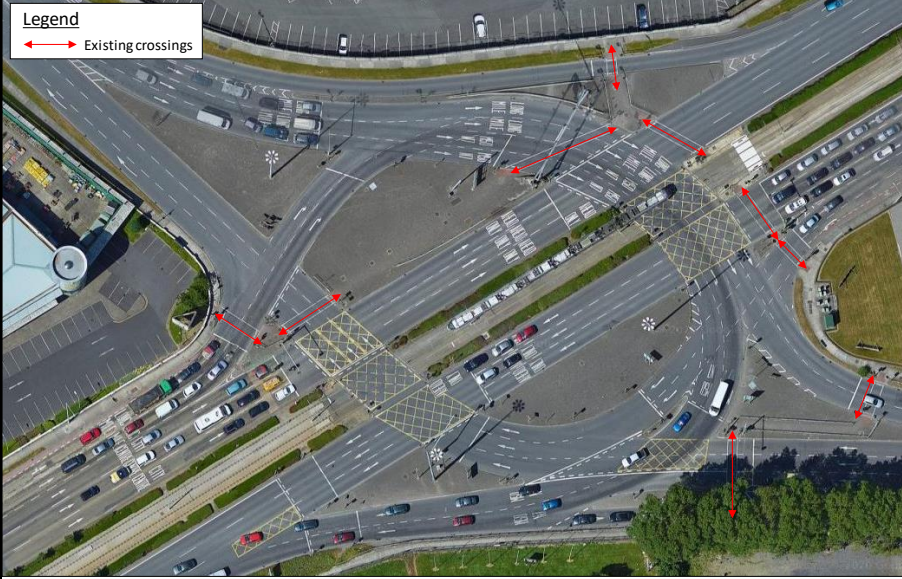
<b>4.3.16 Problem</b>

<b>Location:</b>	At Nangor Road / Naas Road junction	
<b>Drawing:</b>	Sheet 07 of 12	
<b>Summary:</b>	Removal of pedestrian crossings	
<b>Description:</b>		<p>It is proposed to remove that existing at-grade pedestrian crossings with the installation of the pedestrian and cycle bridge over the junction. However, it is likely that pedestrians and cyclists will continue to cross the road at-grade due largely to shorter travel distances (rather than having to negotiate the ramp and bridge). This is likely to result in collisions.</p>
<b>Recommendation:</b>		<p>The at-grade pedestrian crossings should be retained.</p>

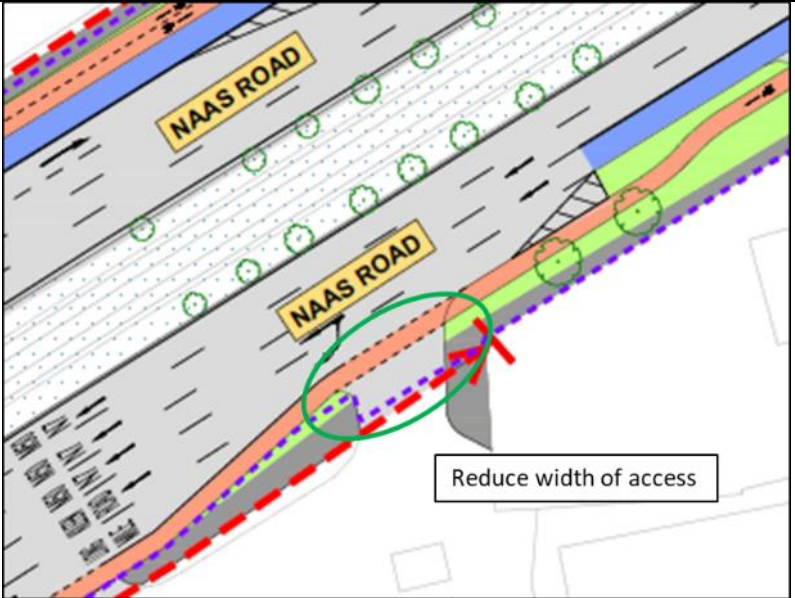
<b>4.3.18 Problem</b>

<b>Location:</b>	Naas Road	
<b>Drawing:</b>	Sheet 07 of 12	
<b>Summary:</b>	Access to Beechlawn Motors encourages fast speeds	
<b>Description:</b>		<p>The orientation and width of the access to Beechlawn Motors from the southwest bound carriageway encourages motorists to enter the access at high speeds. This may result in collision with cyclists on the cycle track or pedestrians on the footpath.</p>
<b>Recommendation:</b>		<p>The width of the access should be reduced to reduce the speed of vehicles at they turn into Beechlawn Motors.</p>

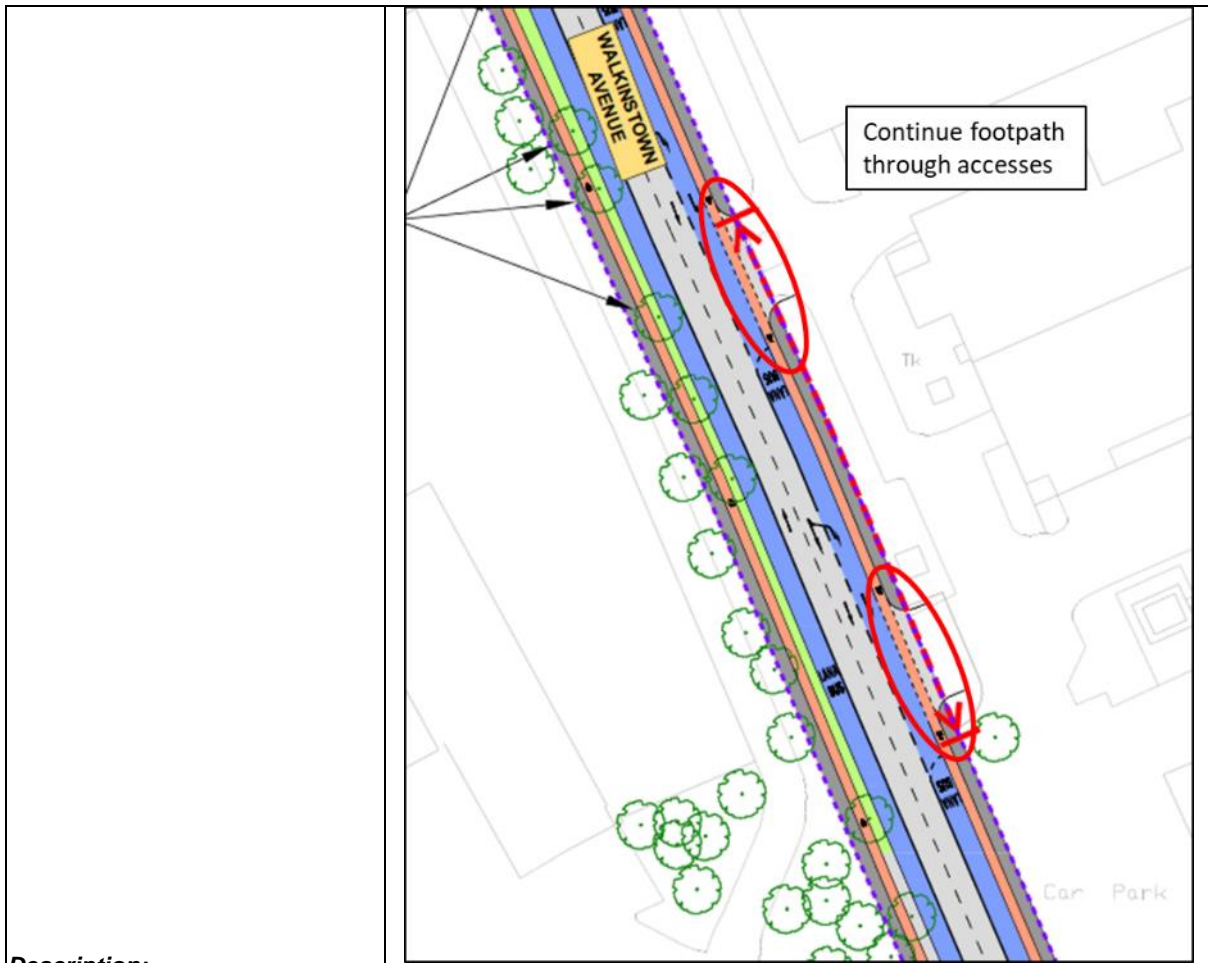
<p><b>4.3.28 Problem</b></p>	
<p><i>Location:</i></p>	<p>Walkinstown Avenue</p>
<p><i>Drawing:</i></p>	<p>Sheet 09 of 12</p>
<p><i>Summary:</i></p>	<p>Footpath discontinued across access points</p>

The footpath along the east side of Walkinstown Avenue should be continued across the junction to ensure pedestrians have priority. Failure to provide a footpath across the accesses would give motorists priority and therefore increase the risk of collisions with pedestrians.

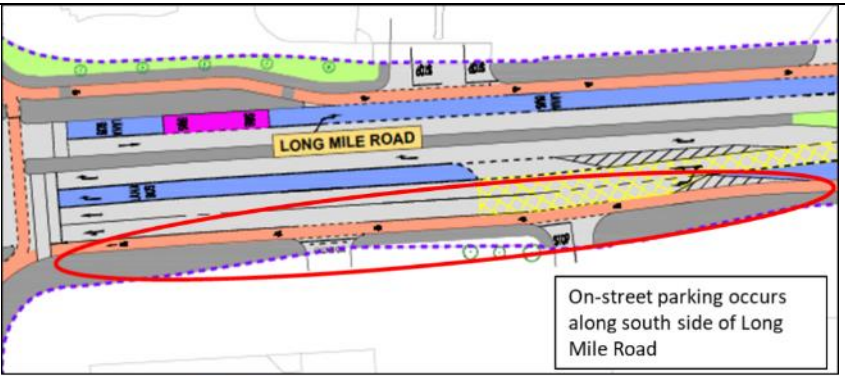
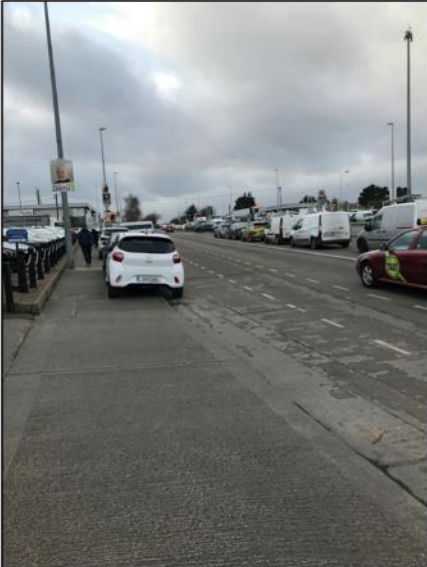
<p><b>4.3.36 Problem</b></p>

<p><i>Location:</i></p>	<p>South side of Long Mile Road</p>	
<p><i>Drawing:</i></p>	<p>Sheet 10 of 12</p>	
<p><i>Summary:</i></p>	<p>Parking on lay-by will be removed</p>	
<p><b>Description:</b></p>

<p>There is a layby fronting a number of commercial units along the south side of Long Mile Road with a number of vehicles noted parked partially on the right turn lane approaching the Walkinstown Avenue junction. It is unclear where these vehicles will be displaced to following the implementation of the scheme. There is a risk that vehicles will continue to park at this location thus increasing the risk of collisions.</p>		
<p><b>Recommendation:</b></p>		
<p>Parking enforcement measures should be implemented to prevent vehicles from parking along the south side of the Long Mile Road.</p>

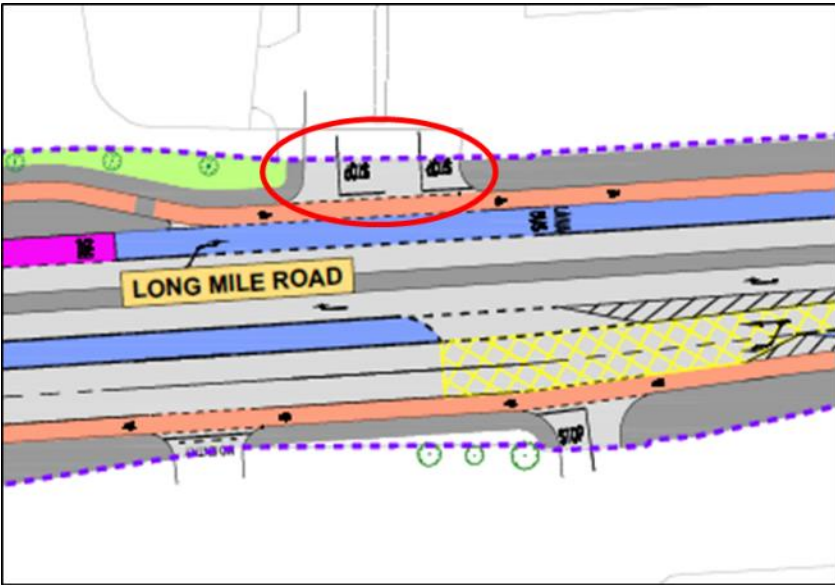
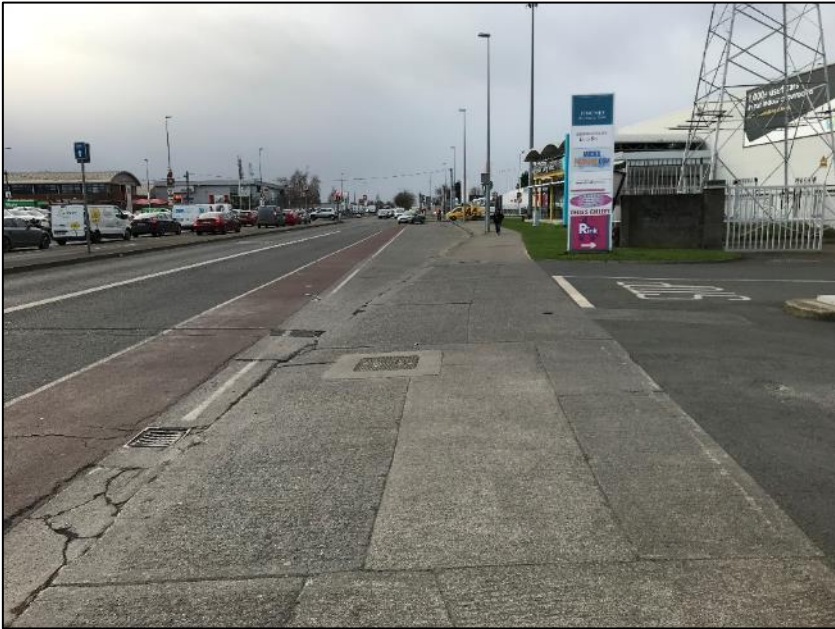
<p><b>4.3.38 Problem</b></p>	
<p><b>Location:</b></p>	<p>Long Mile Road at Finches Business Park Road and entrances to business</p>
<p><b>Drawing:</b></p>	<p>Sheet 10 of 12</p>
<p><b>Summary:</b></p>	<p>Discontinuation of footpath across entrances</p>

<p><b>Description:</b></p> <p>The footpath across the accesses to Finches Business Park Road and Des Kelly Interiors had been omitted. This absence of a footpath at this location is likely to result in conflicts between vehicle accessing/departing these properties and pedestrians.</p>	
<p><b>Recommendation:</b></p> <p>The footpath should be continued across the accesses thus giving priority to pedestrians.</p>

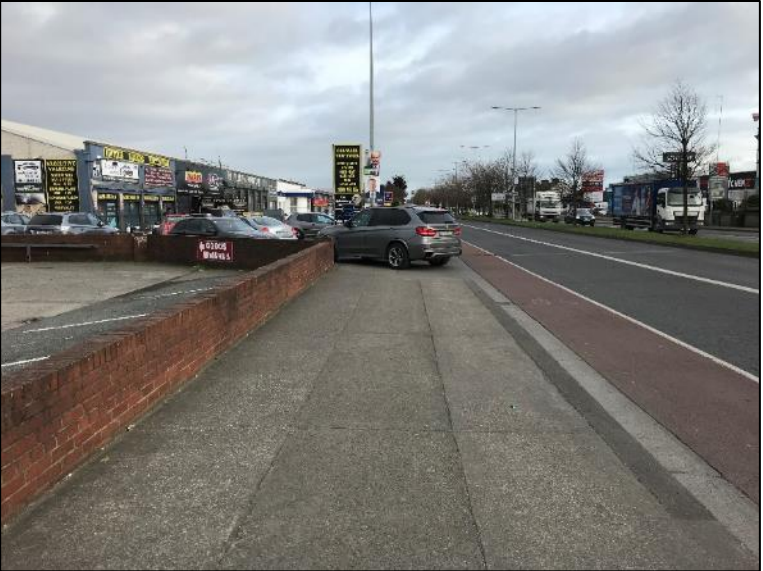
<p><b>4.3.39 Problem</b></p>		 
<p><i>Location:</i></p>	<p>Long Mile Road at access to car wash facility</p>	
<p><i>Drawing:</i></p>	<p>Sheet 10 of 12</p>	
<p><i>Summary:</i></p>	<p>Queuing traffic extends onto footpath and encroaches on cycle and bus lane</p>

<p><b>Description:</b></p> <p>It was observed that vehicles queuing at the car wash facility off Long Mile Road (eastbound carriageway) extend back across the footpath and encroach on the bus and cycle lane. This will obstruct the flow of pedestrians, cyclists and buses. Sudden movements to avoid this queuing could result in collisions at this location. In addition pedestrians may be forced to enter the adjacent cycle track/carriageway to continue their journey resulting in potential conflict with cyclists/vehicles.</p>		
<p><b>Recommendation:</b></p> <p>The premises should be requested to provide a traffic/access management plan that will keep all traffic within their premises.</p>

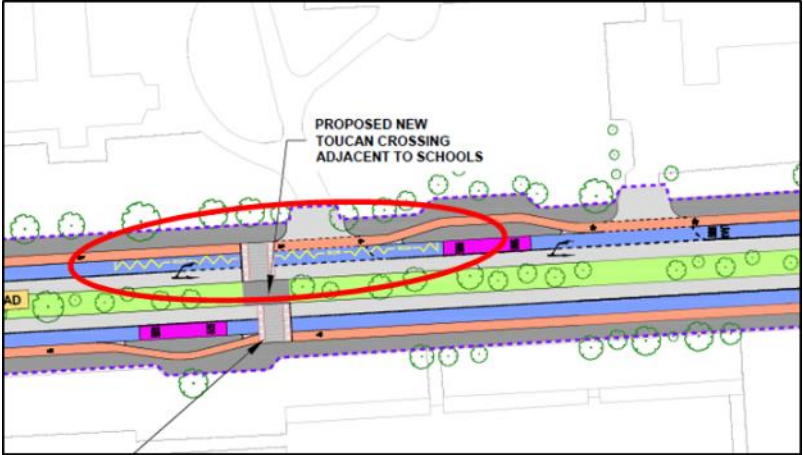
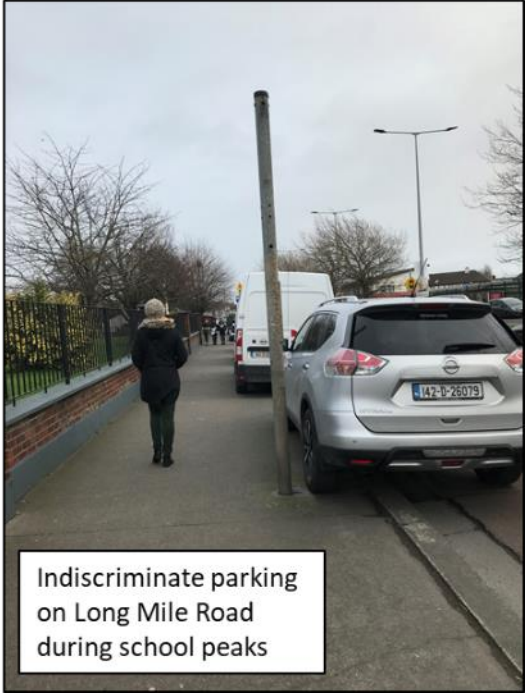
<p><b>4.3.40 Problem</b></p>	
<p><b>Location:</b></p>	<p>Drimnagh Castle Primary School</p>
<p><b>Drawing:</b></p>	<p>Sheet 10 of 12</p>
<p><b>Summary:</b></p>	<p>Indiscriminate parking on the Long Mile Road in proximity to the school</p>
<div style="display: flex; justify-content: space-around;"> <div style="width: 45%;">

</div> </div>	
<p><b>Description:</b></p> <p>On-street parking on Long Mile Road at Drimnagh Castle Primary School was observed. Vehicle parking at this location would obstruct both cyclists and buses on the new scheme. Buses and cyclists would be required to deviate suddenly from their designated lanes possibly resulting in conflicts with traffic on the main east bound lane.</p> <p>Furthermore, parked vehicles are likely to obscure visibility between approaching eastbound traffic and pedestrians crossing at the Toucan Crossing. This may result in collisions between motorists and pedestrians.</p>

<p><b>Recommendation:</b></p> <p>Parking enforcement measure should be implemented to prevent motorists from parking on the Long Mile Road adjacent to the school.</p>

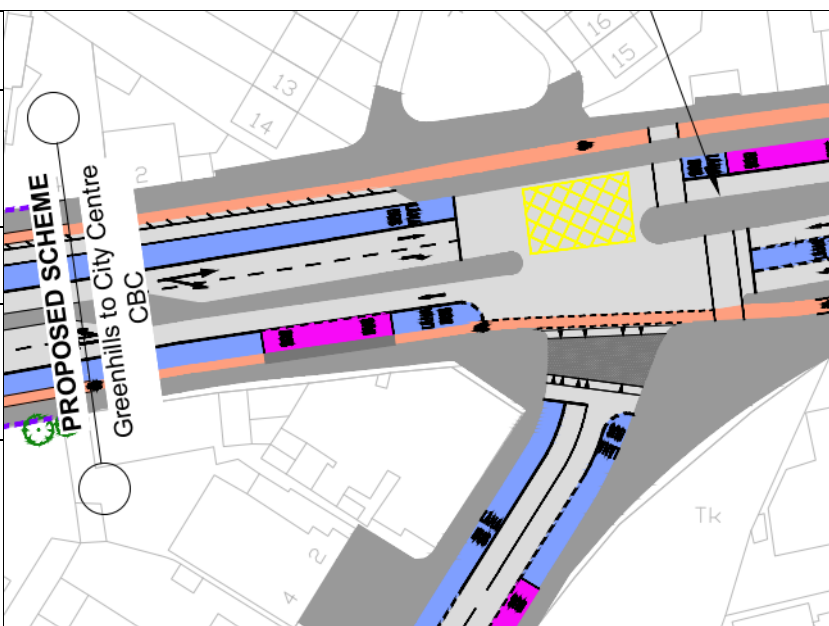
<b>4.3.45 Problem</b>	
<b>Location:</b>	Long Mile Road/Walkinstown Road/Drimnagh Road junction
<b>Drawing:</b>	Sheet 12 of 12
<b>Summary:</b>	Westbound bus stop located close to Walkinstown Road junction

<b>Description:</b>	
<p>The westbound bus stop on Long Mile Road is located in close proximity to the Walkinstown Road junction. There are concerns that this may result in buses queuing back to the junction while passengers' mount/dismount. This is likely to result in congestion at the junction where buses approaching from the east will be required to wait while buses queue at the bus stop. Buses approaching from Walkinstown Road and Drimnagh Road may get caught on the junction as they will be unable to access the bus lane. This may result in appropriate or dangerous turning movements which may lead to collisions.</p>	
<b>Recommendation:</b>	
<p>The bus stop should either be relocated further to the west or extend the bus stop so it can accommodate additional buses thus reducing impacts on the operation of the junction.</p>

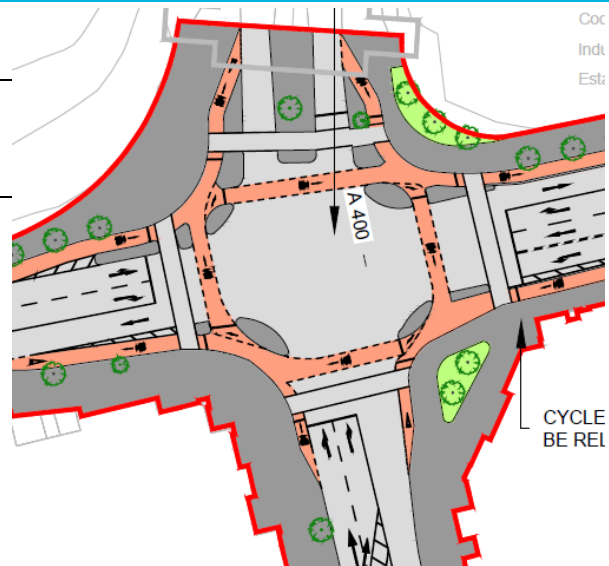
**Summary:** Tactile paving is not indicated

The proposals are to provide a variety of crossing types and shared areas across the scheme. It is necessary to ensure that the appropriate tactile paving is provided at these locations to ensure that pedestrians, particularly the vision impaired, are aware that they are entering a shared space or using a controlled / uncontrolled crossing. Should incorrect or no tactile paving be provided this could result in these users unknowingly walking into the carriageway resulting in a vehicle pedestrian collision or a cycle track and being struck by a cyclist.

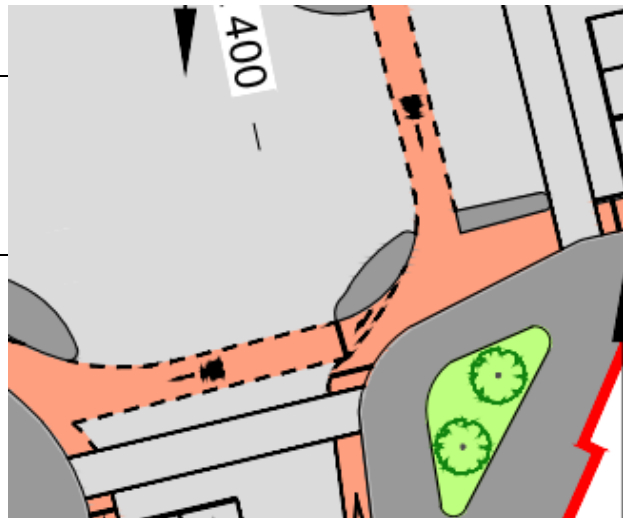
**Summary:** Unclear if sufficient stacking capacity for right turning cyclists.

The scheme proposes to provide dedicated cycle facilities and remove cycle traffic from the mainline flow of traffic. It is unclear if there is sufficient stacking capacity, at some locations, for cyclists intending to turn right at the corners of the junctions, as illustrated in the extract above on the southeast corner of Belgard Square North/Belgard Square West. If sufficient stacking capacity or sufficient width are not provided at these locations, this could result in instances where cyclists that are waiting to turn right are struck by passing cyclists or cyclists that are continuing straight through could collide with the kerb.

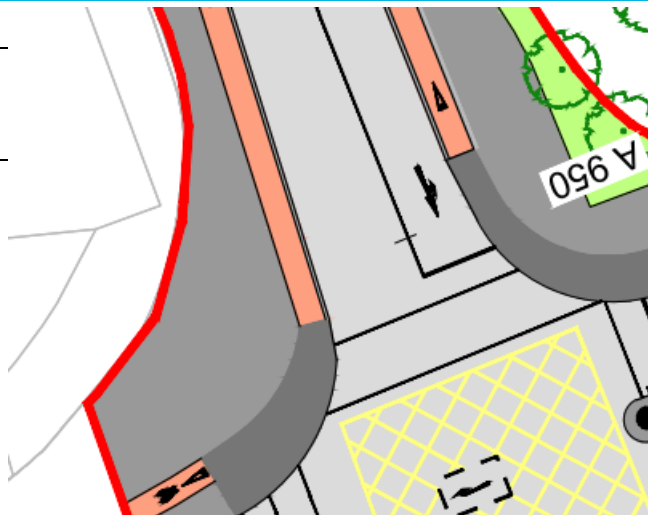
**Summary:** Lack of tactile paving at end of Cycle Lanes into Shared Use areas.

The cycleway traverses the signalised pedestrian crossing on the Lucan Road. Stop lines are provided within the cycleway in both directions in advance of the pedestrian crossing. When the pedestrian phase is called, the traffic signals will turn red. These signal aspects will be visible to all eastbound traffic.

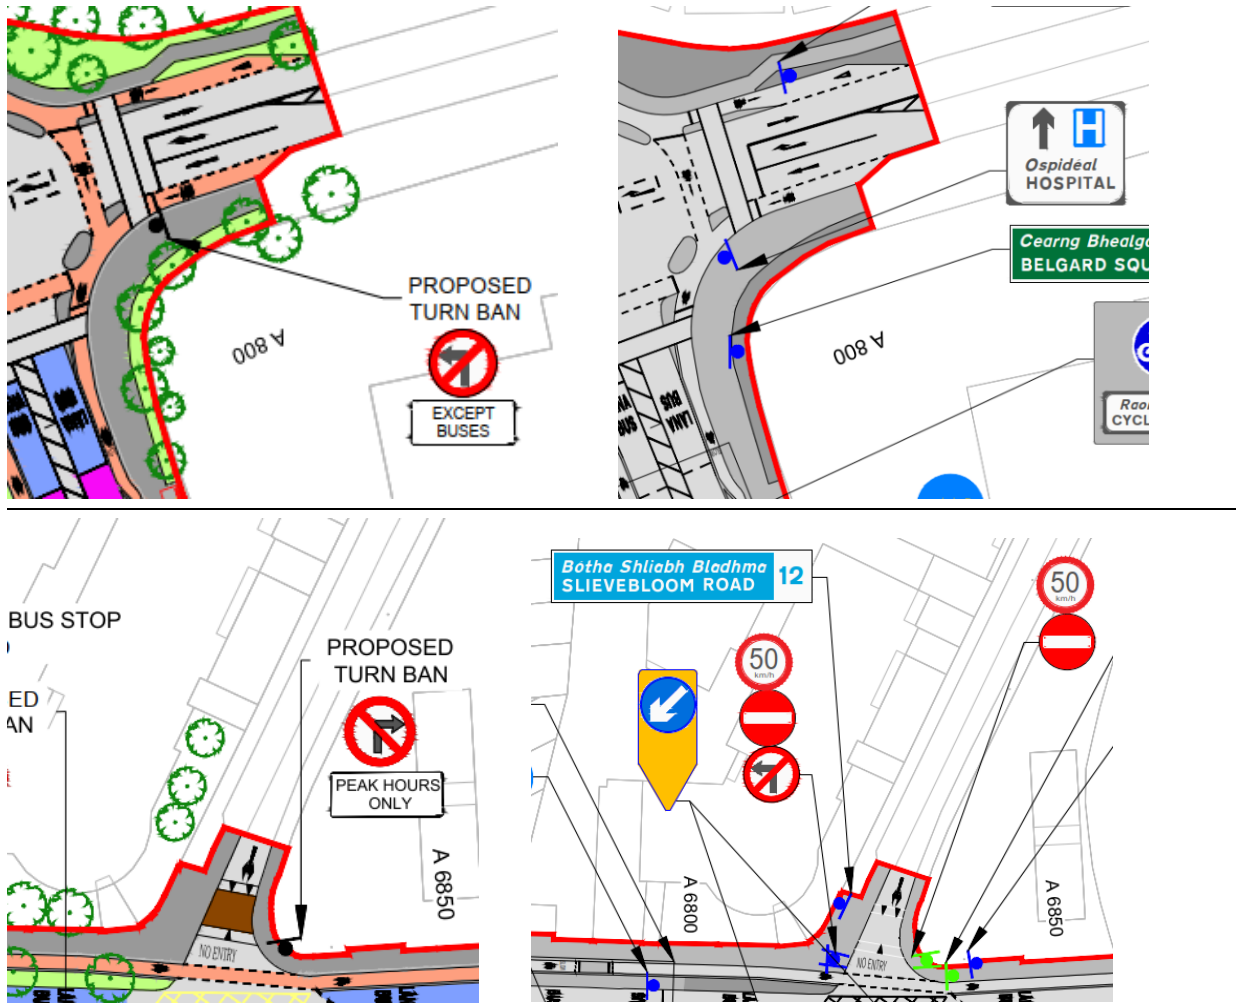
**Summary:** Conflicting/missing signage/ on different series dwgs

It is noted that there are several inconsistencies between the separate drawing series. For example, as shown above on the westbound approach on the Belgard Square North Road to the junction with the Belgard Square East, when comparing the General Arrangement drawing to the Traffic Signs & Road Marking drawing, the signage is different for each drawing. Inconsistencies in layout arrangement on construction drawings can lead to appropriate signage not being provided which could result in driver confusion or taking inappropriate manoeuvres which could lead to collisions.

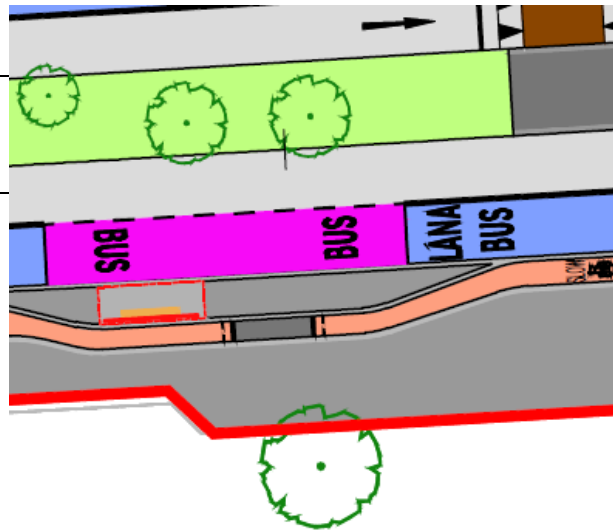
**Summary:** No yield, direction or symbol road markings are provided on the cycle lane at the bus stop crossings.

It is proposed to provide raised shared surfaces at the bus stops located along the route of the cycle tracks / lanes to facilitate pedestrian access from the footpath to the floating bus islands. On approach to these shared surfaces, it is noted that no yield, arrow or cycle symbol are indicated on the cycle lanes. These road markings inform cyclists that they are entering a shared space and may be required to yield to pedestrians. A lack of these road markings could lead to cyclists failing to yield resulting in a pedestrian cyclist collision at these locations.

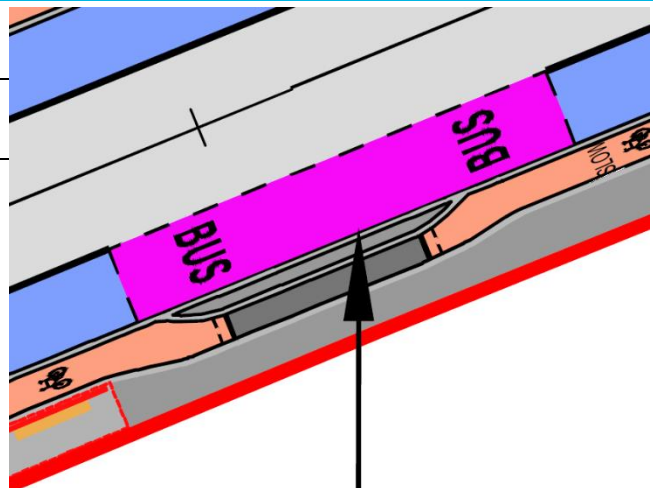
**Summary:** Lack of adequate width on island can lead to cyclist/pedestrian conflicts.

The segregation island at the bus stops, for example on Greenhills Rd west of Mayberry Road, and Calmount Road, tapers to a small radius to the front of the bus stop and appears to be less than the recommended width, particularly at the front of the bus stop.

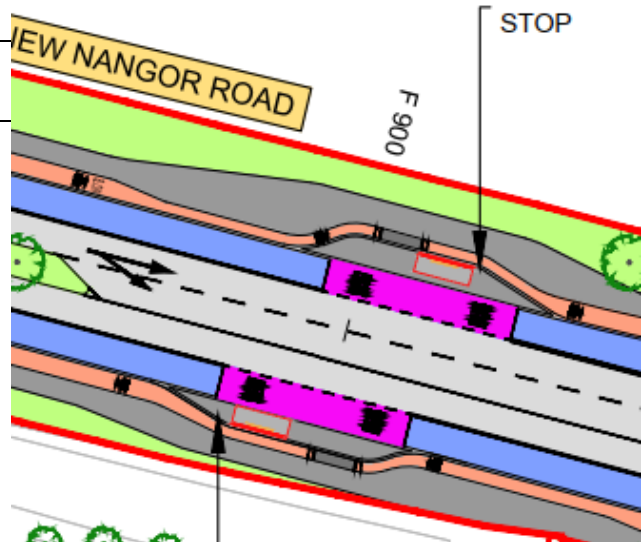
**Summary:** Risk of cyclists losing control due to geometry of cycleway, leading to falls.

There are several locations along the route where the cycle track narrows on the approach to a bus stop and the geometry of the radii of the uni-directional cycle route appears tight. This could cause issues for users on longer bicycles, such as recumbent, cargo or tandem bicycles.

This could lead to cyclists losing control, particularly in wet conditions, which could lead to cyclist falls, resulting in cyclist injuries.

It is recommended that swept path analysis is undertaken on the proposed layouts using different types of bicycles and that the design is appropriately amended, if required.

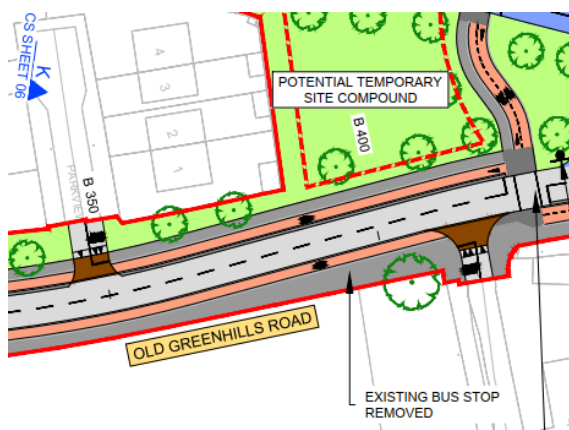
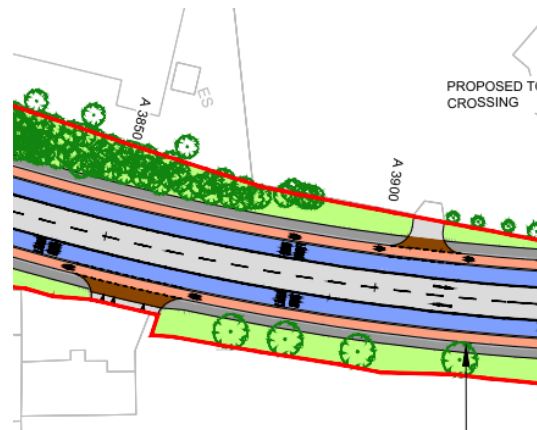
**Summary:** Conflicting access arrangements across cycle lane

It is noted that there are different forms of junction arrangements across the cycle lanes. For example, as shown above on the Old Greenhills Road west of the M50 overbridge, a raised table crossing is provided to the edge of the carriageway whereas on the Greenhills Road just west of the M50 overbridge, the raised table crossing is provided to the edge of the nearside edge of the cycle lane.

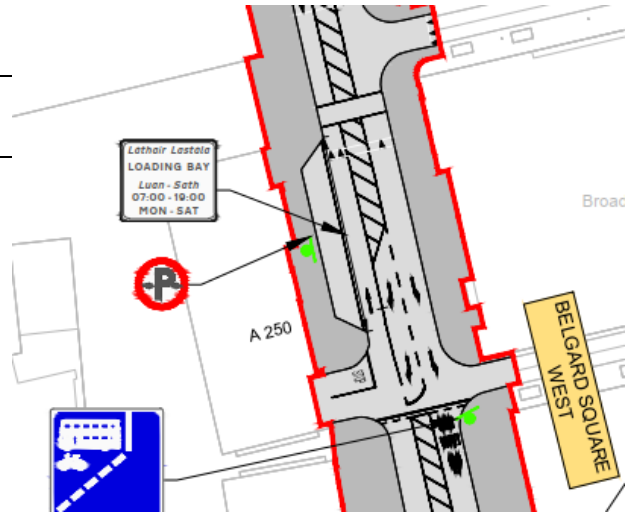
Summary: There is no 'No Entry' signage provided in advance of bus lane.

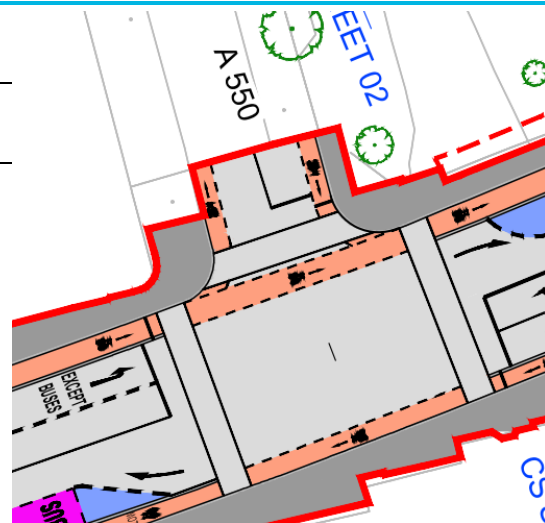
Summary: Conflicts between eastbound vehicles and westbound cyclists from side road.

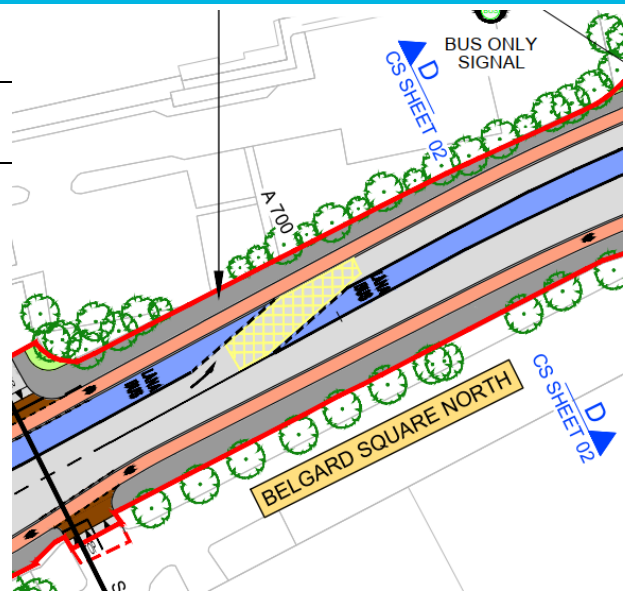
*Summary:* Conflicts between eastbound buses and vehicles on adjacent lane as they switch lanes.

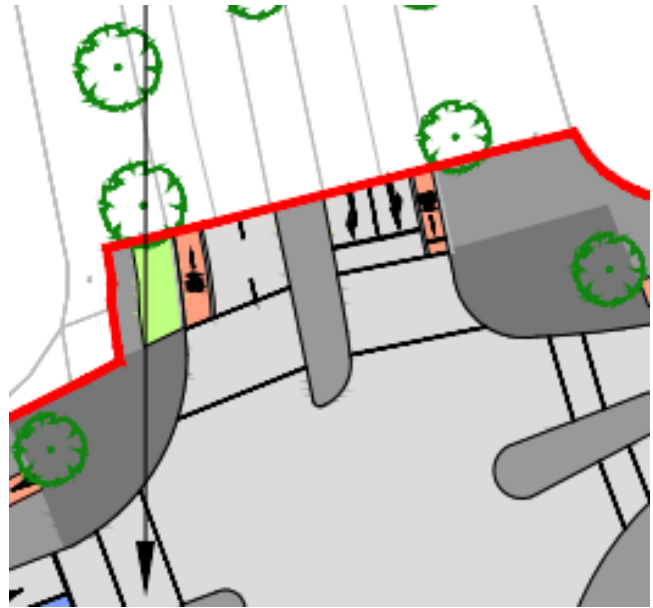
**Summary:** Length of pedestrian crossing is very long for a single-phase crossing.

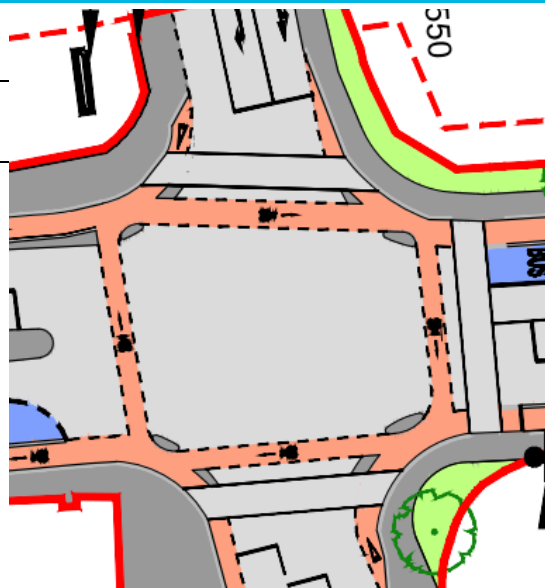
**Summary:** No stacking area is provided for right turning cyclists

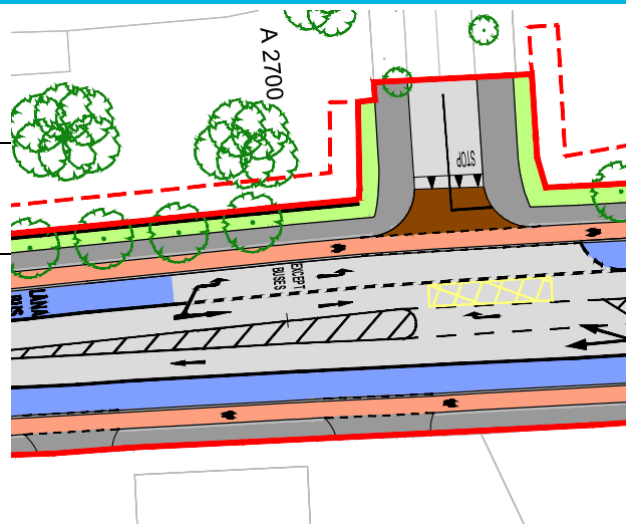
**Summary:** Road marking may confuse drivers

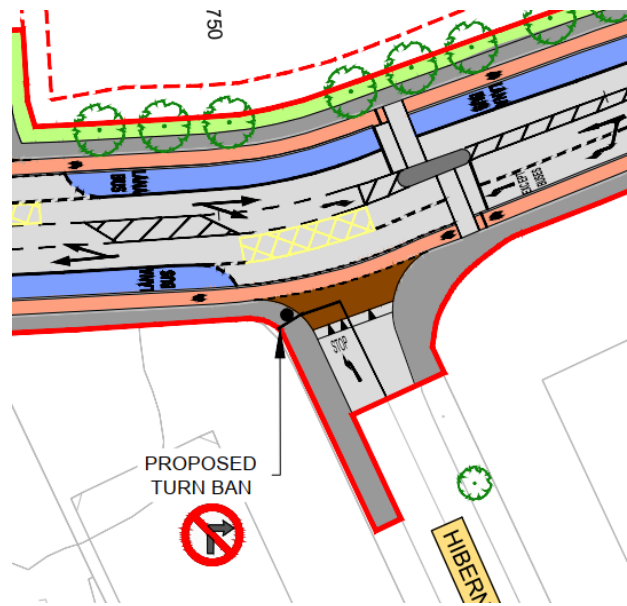
**Summary:** Right-turn onto Greenhills Road prohibited

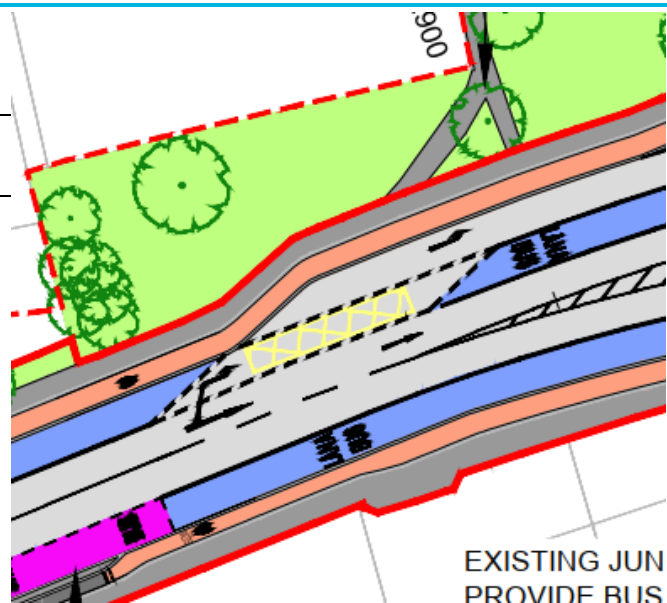
**Summary:** Conflicts between northbound buses and vehicles on adjacent lane as they switch lanes.

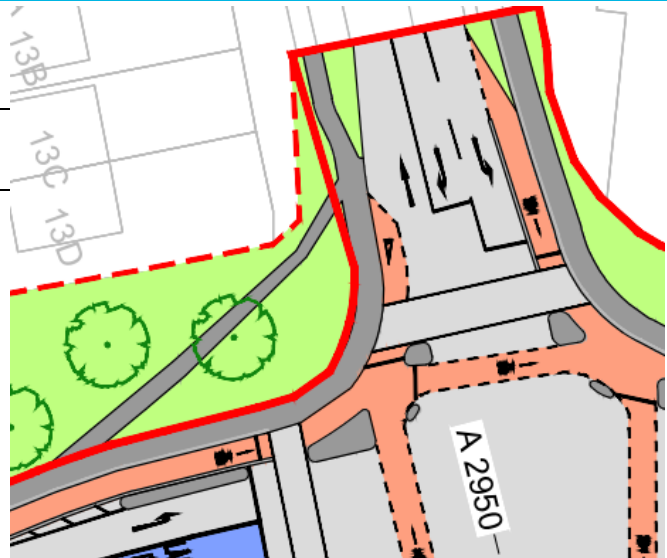
**Summary:** Left turning HGVs may conflict with waiting cyclists/vehicles.

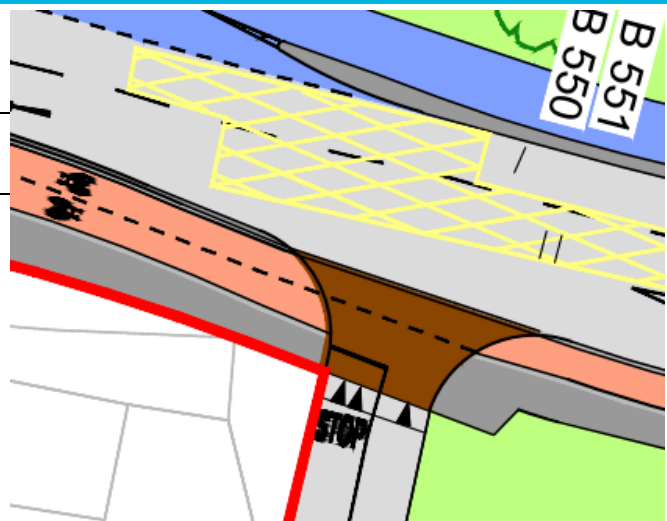
**Summary:** Cycle route terminates without onward direction.

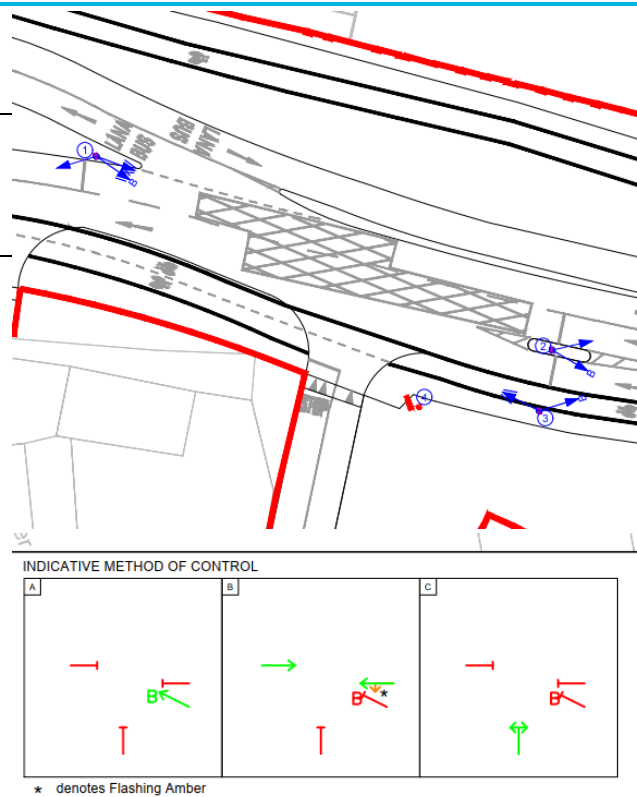
**Summary:** Form of vehicle control from Termon Lane is unclear.

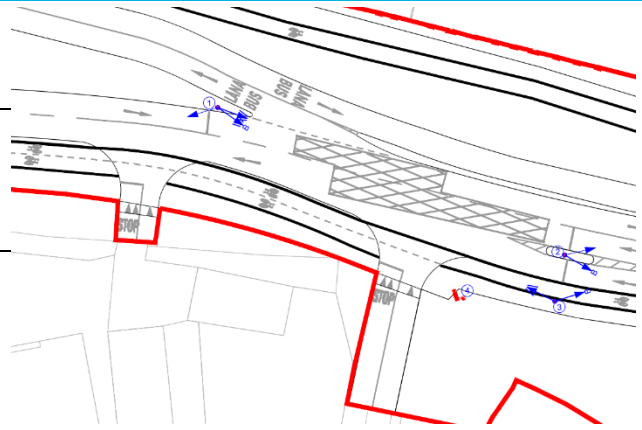
**Summary:** Secondary signals may not be clearly visible to drivers.

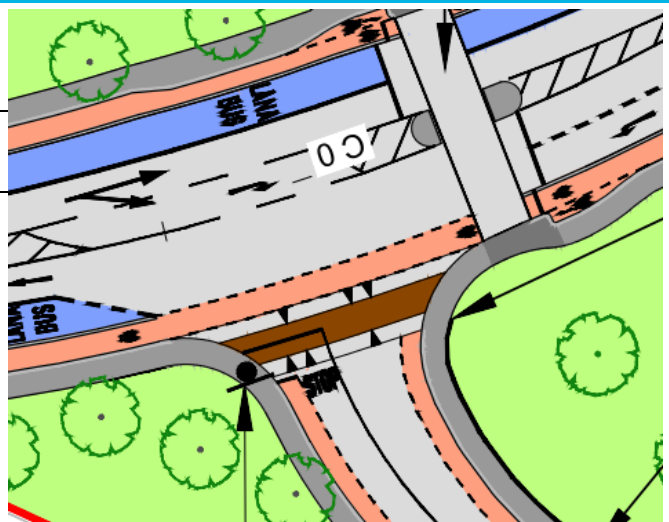
**Summary:** No linkage provided between cycle routes.

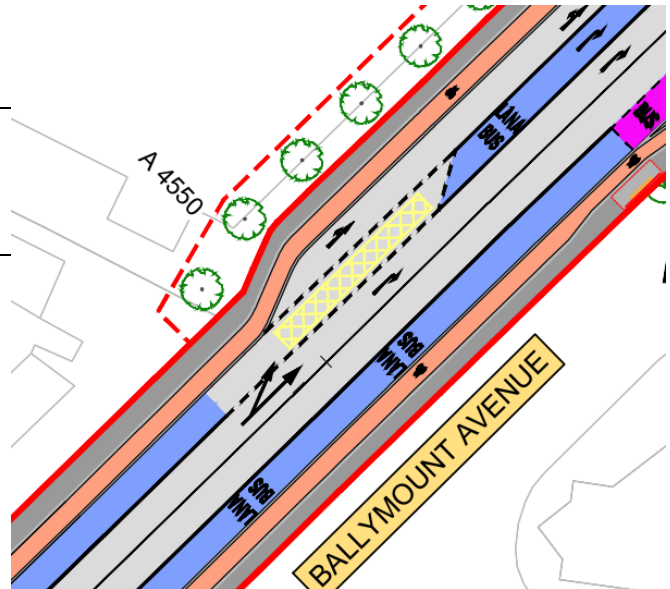
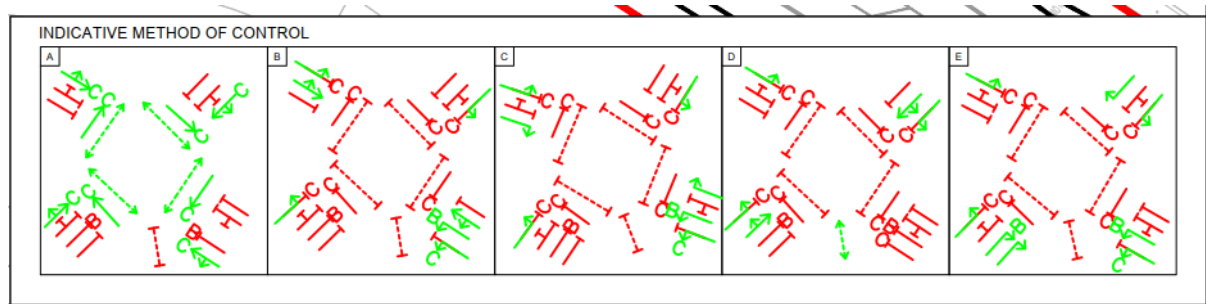
**Summary:** Northbound buses may conflict with left turning traffic.

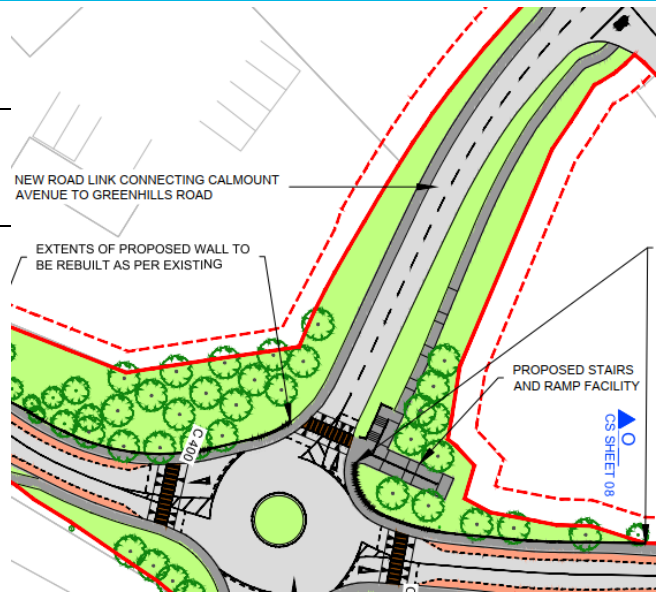
**Summary:** No provision for cyclists at the proposed roundabout or link road.

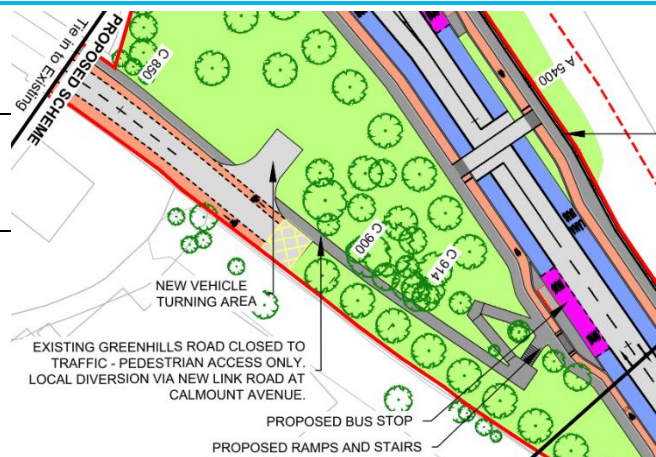
**Summary:** No provision for cyclists to Calmount Road.

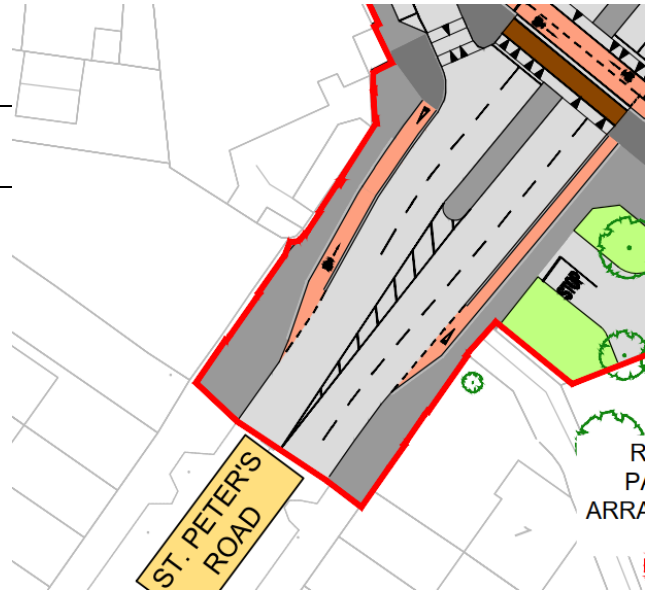
**Summary:** Absence of road marking to indicate merging lanes

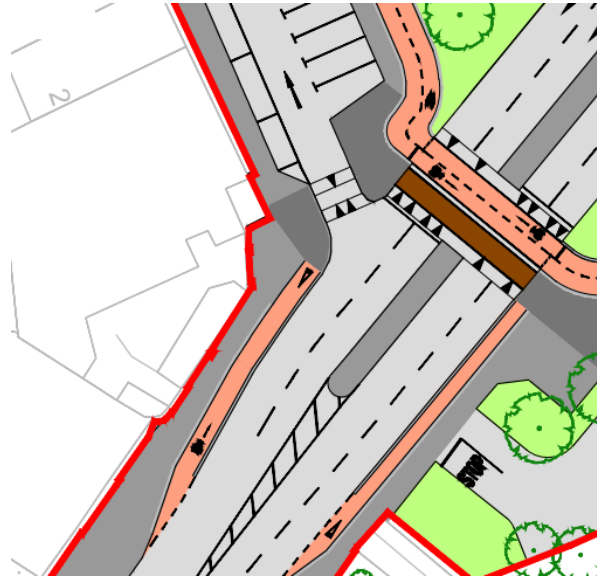
**Summary:** Northbound cyclists on St Peter's Road have no access to cycle track.

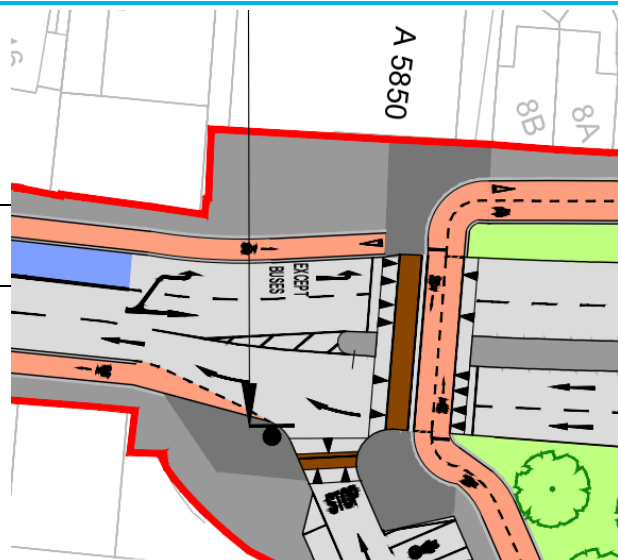
**Summary:** Two lane exit may lead to side swipe or cyclist collisions.
