# Stage 1 Road Safety Audit

Tallaght/Clondalkin to City Centre Core Bus Corridor  
BCIDA – ACM - STY\_ZZ – 0809\_XX\_00 – RP – ZZ – 0001

Client – National Transport Authority  
Stage – Stage 1

Date (March 2023)

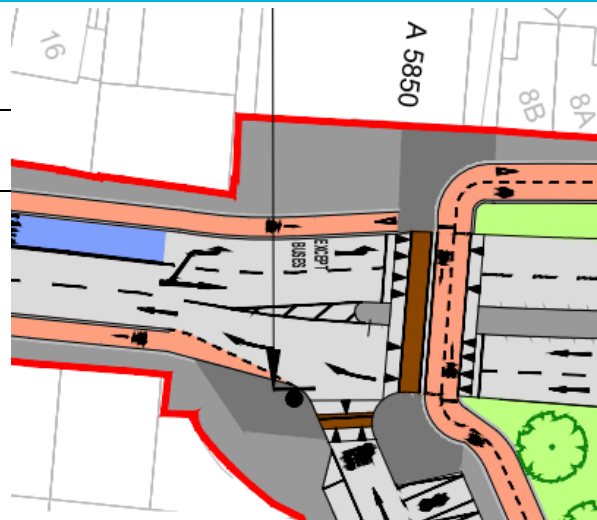
**Summary:** Unclear how cyclists access the cycle track.

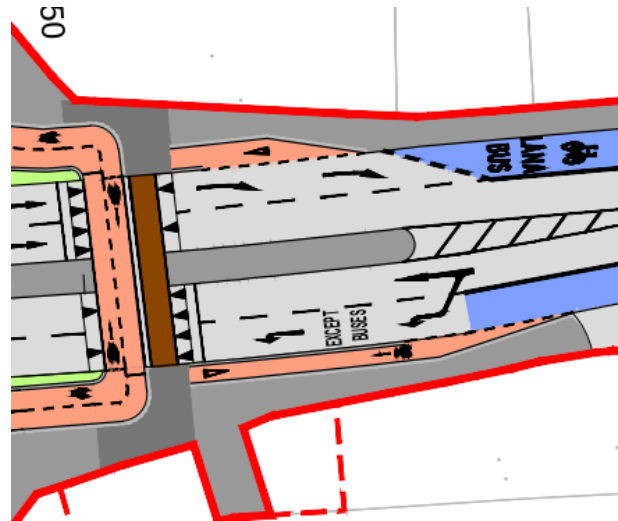
**Summary:** Conflicts between cyclists merging online and vehicles on adjacent lane.

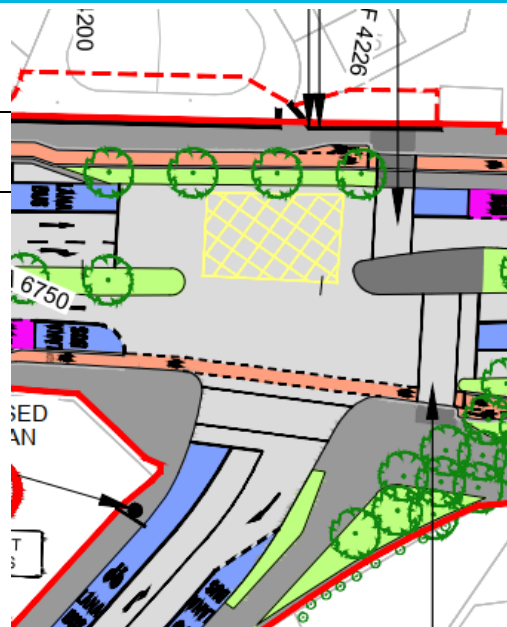
**Summary:** Turning vehicles may cause side impact collisions.

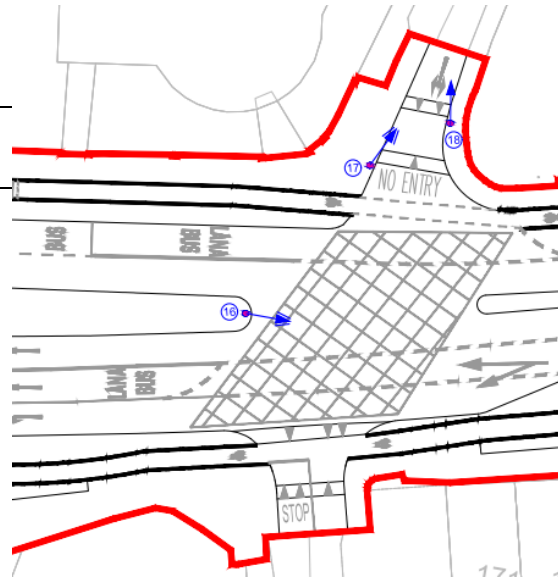
**Summary:** Form of vehicle control from Balfe Lane is unclear.

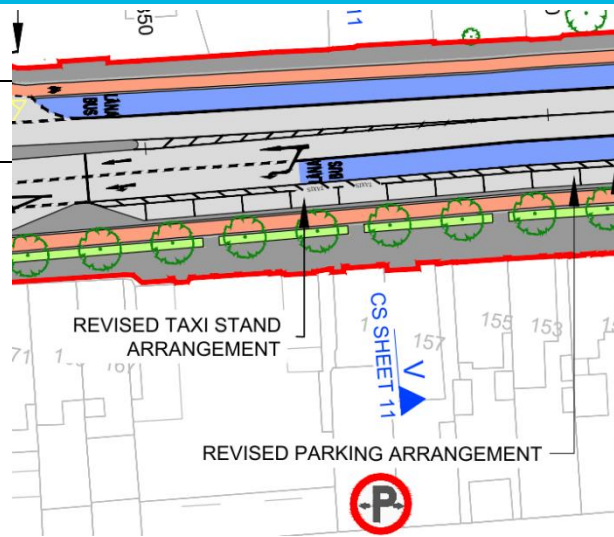
**Summary:** Risk of pedestrian collisions at Taxi rank.

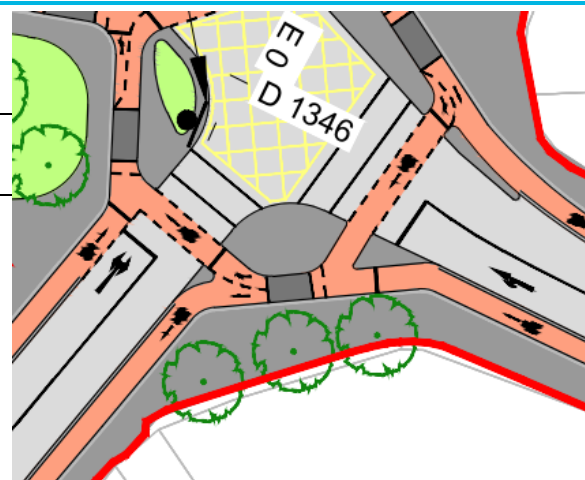
**Summary:** Turning vehicles may have insufficient space.

The left slip lane from Kildare Road to St Mary's Road has been replaced. It is unclear if HGVs or other large vehicles can safely turn left from Kildare Road into St Mary's Road. Tracking for large vehicles has not been provided for this turning manoeuvre.

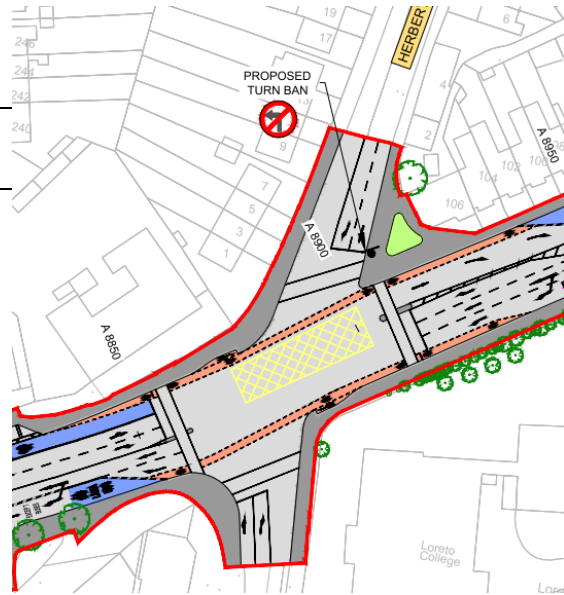
**Summary:** Unclear cycle lane crossings.

If inadequate direct cycle routes and signage are not adequately provided, it result in cyclists entering onto the carriageway where it is not safe to do so, which could lead to cyclist/vehicular collisions.

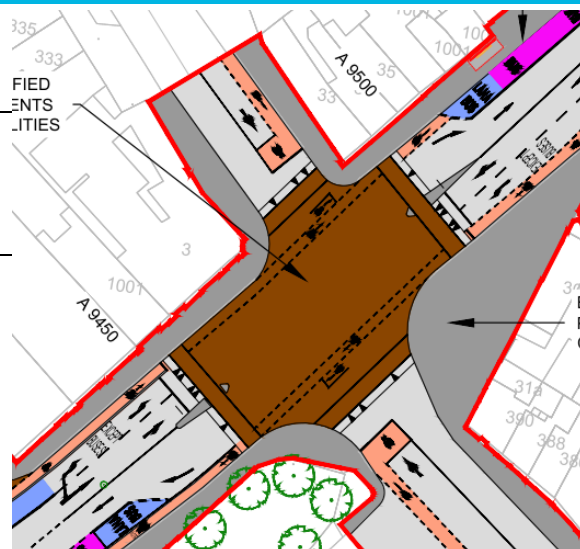
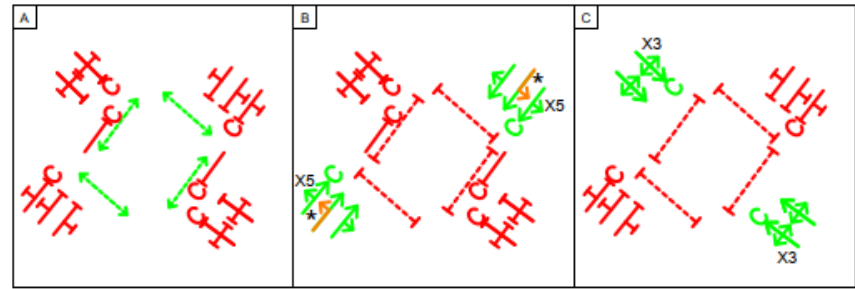
**Summary:** Cycle signal control from South Circular Road places cyclists in conflict with vehicles.

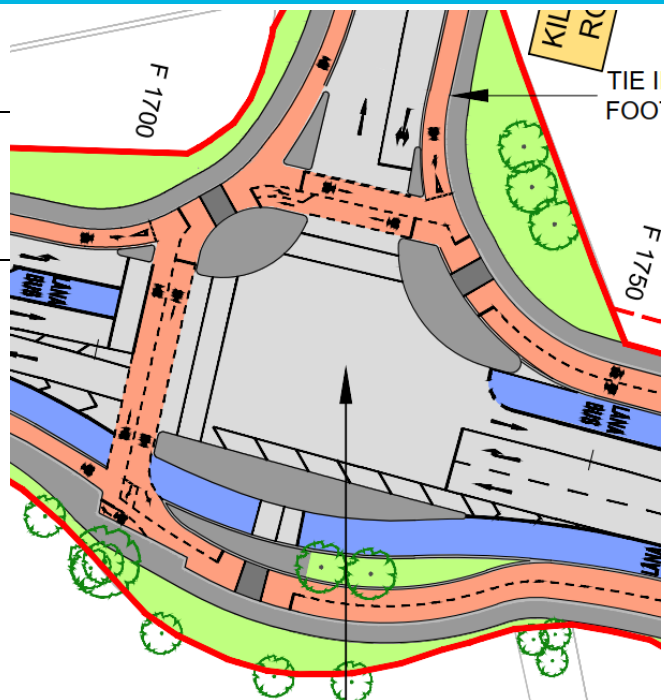
**Summary:** Length of pedestrian crossing is too long for a single-phase crossing.

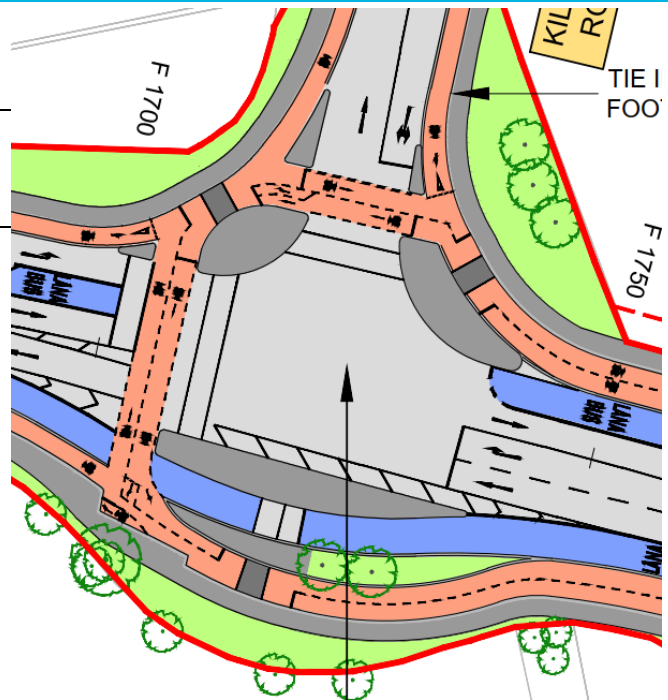
**Summary:** Segregation island may not be wide enough to accommodate all NMUs.

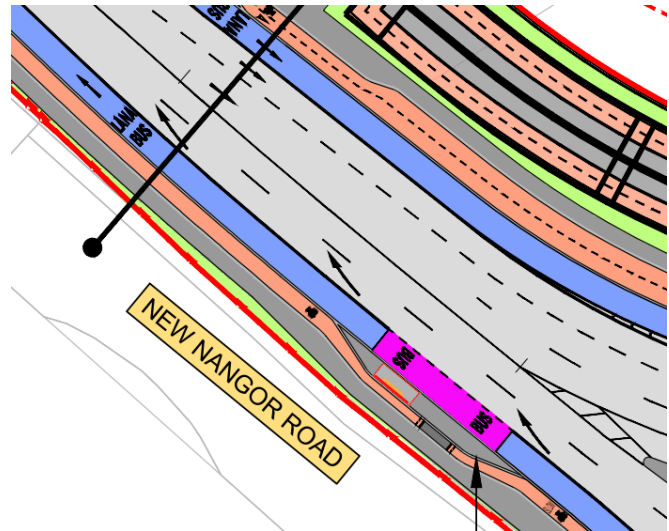
**Summary:** Merge arrows are proposed incorrectly.  
Layout of merge arrows may lead to side impact collisions.

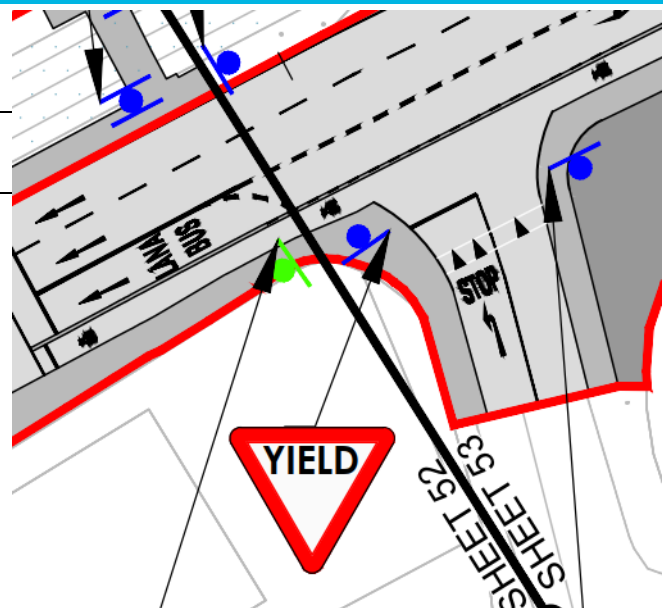
**Summary:** Different road marking and signage at junction.

There is YIELD road sign and a STOP road marking provided at the junction between Naas Road and Robinhood Road in advance of the cycle track on Naas Road. This signage is conflicting to motorists. Failure to provide clear consistent warning signage for traffic departing Robinhood Road may cause confusion at the junction and may result in collisions between motorists and cyclists.

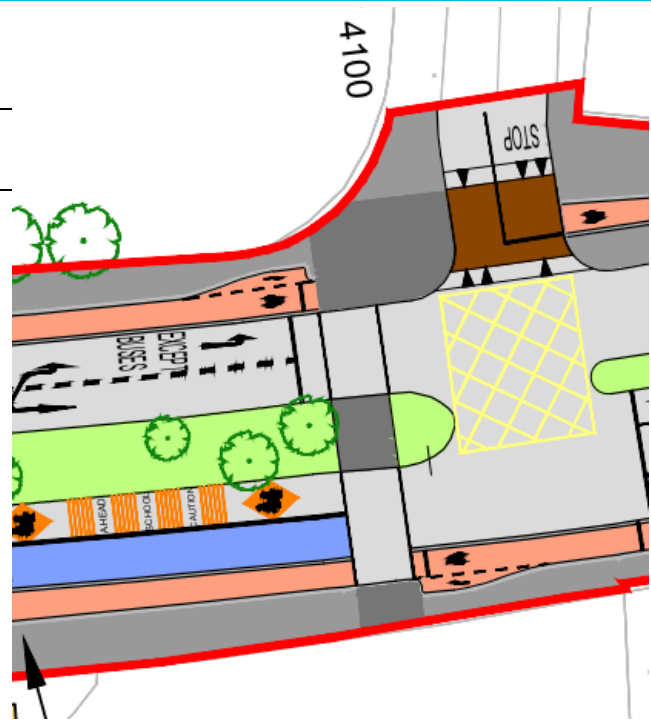
**Summary:** Cycle track accesses footpath may cause pedestrian/cyclist conflicts
