**Appendix E4**  
Report No. 20-0399C  
BusConnects Route 8  
Tallaght/Clondalkin  
to City Centre -  
Ground Investigation

## **Bus Connects Route 8 Tallaght/Clondalkin to City Centre – Ground Investigation**

**Report No.:** 20-0399C

**Date:** December 2020

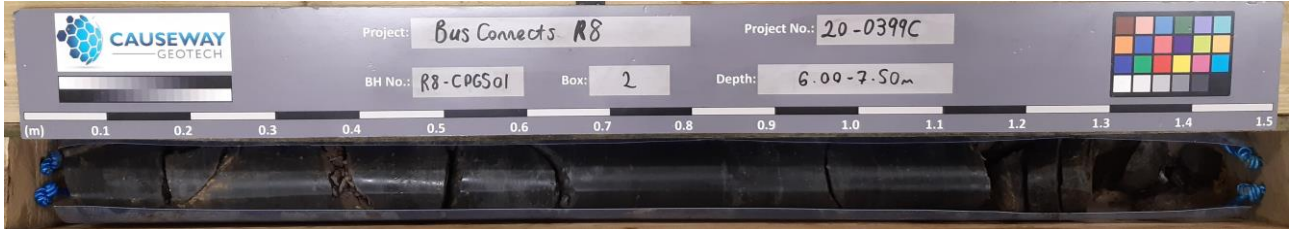
R8-CPGS01 Box 2 6.00-7.50m

5.75	C								1. 0 to 15 degree bedding fractures, medium spaced (45/220/720), plana and slightly undulating, smooth with brown clay deposits on fracture surfaces.

5.90	C								2. 35 to 40 degree joints, widely spaced (240/615/>3400), slightly undulating, smooth with brown clay infill up to 5mm between fracture surfaces.

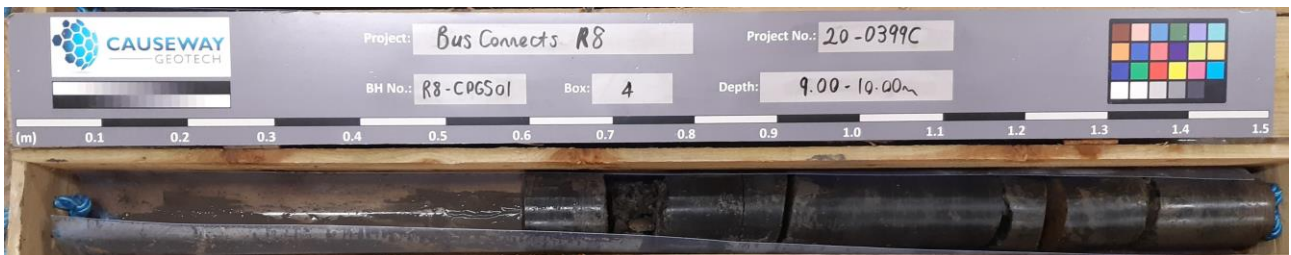
R8-CPGS01 Box 4 9.00-10.00m

Depth (m)	Samples / Field Records	TCR	SCR	RQD	FI	Casing Depth (m)	Water Depth (m)	Level mOD	Depth (m)	Legend	Description	Water	Backfill
9.35	C	96	96	76	8			38.19	10.00		Medium strong (locally strong) thinly bedded dark grey LIMESTONE. Partially weathered: slightly reduced strength, slightly closer fracture spacing with brown clay deposits. Discontinuities: 1. 0 to 15 degree bedding fractures, medium spaced (45/220/720), plana and slightly undulating, smooth with brown clay deposits on fracture surfaces. 2. 35 to 40 degree joints, widely spaced (240/615/>3400), slightly undulating, smooth with brown clay infill up to 5mm between fracture surfaces. 3. At 5.25m to 5.55m and 8.60m to 8.85m: 75 degree joints, undulating, smooth with brown clay infill up to 32mm between joint surfaces.  End of Borehole at 10.00m		
10.00

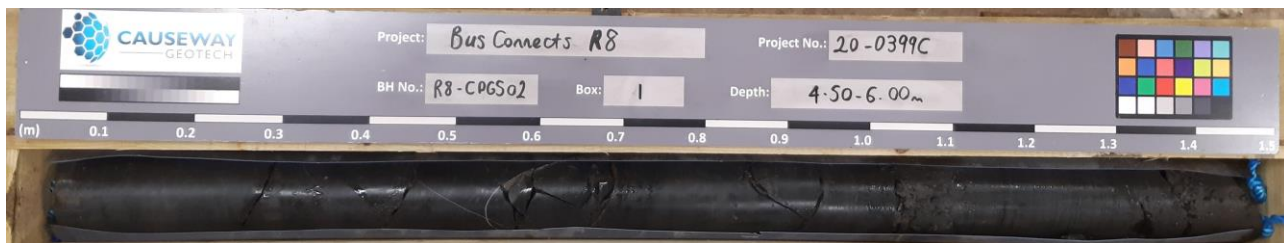
R8-CPGS02 Box 1 4.50-6.00m

3.00	B8	43.09	4.50	Grey LIMESTONE. (Driller's description)									
3.00 - 3.40	U13	Ublow=30 80% Strike at 3.40m. Slow seepage at 3.60m	Dry	Dry	43.99	3.60	Medium strong (locally weak) thinly bedded dark grey LIMESTONE. Partially weathered: slightly reduced strength, closer fractures spacing with localised brown clay deposits and brown staining on fracture surfaces.

4.00	B9				42.04	5.55	Discontinuities: 1. 10 to 15 degree bedding fractures, medium spaced (100/210/270), slightly undulating, smooth with brown clay infill up to 4mm between fracture surfaces and brown staining on fracture surfaces. 2. 60 to 70 degree joints, medium spaced (90/260/350), slightly undulating, smooth with brown clay deposits on joint surfaces and brown staining on joint surfaces.

4.00	D12				42.04	5.55	Medium strong (locally weak) thinly bedded dark grey LIMESTONE. Partially weathered: slightly reduced strength, closer fracture spacing with localised brown clay deposits and brown staining on fracture surfaces.

4.00 - 4.08	SPT(S) N=50 (25 for 25mm/50 for 50mm) Hammer SN = 0643				42.04	5.55	Discontinuities: 1. 10 to 20 degree bedding fractures, closely, spaced (20/150/310), slightly undulating, smooth with patchy brown clay deposits and brown staining on fracture surfaces. 2. 60 to 85 degree joints, probably widely spaced, slightly undulating to undulating, smooth with brown staining on joint surfaces and localised brown clay infill up to 12mm between joint surfaces.

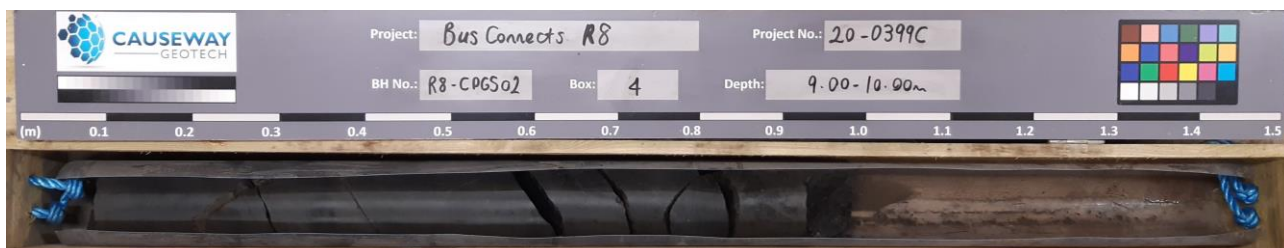
R8-CPGS02 Box 4 9.00-10.00m

Depth (m)	Samples / Field Records	TCR	SCR	RQD	FI	Casing Depth (m)	Water Depth (m)	Level mOD	Depth (m)	Legend	Description	Water	Backfill
9.35	C	96	96	81	8			37.59	10.00		Medium strong (locally weak) thinly bedded dark grey LIMESTONE. Partially weathered: slightly reduced strength, closer fracture spacing with localised brown clay deposits and brown staining on fracture surfaces. Discontinuities: 1. 10 to 20 degree bedding fractures, closely, spaced (20/150/310), slightly undulating, smooth with patchy brown clay deposits and brown staining on fracture surfaces. 2. 60 to 85 degree joints, probably widely spaced, slightly undulating to undulating, smooth with brown staining on joint surfaces and localised brown clay infill up to 12mm between joint surfaces. End of Borehole at 10.00m		
10.00

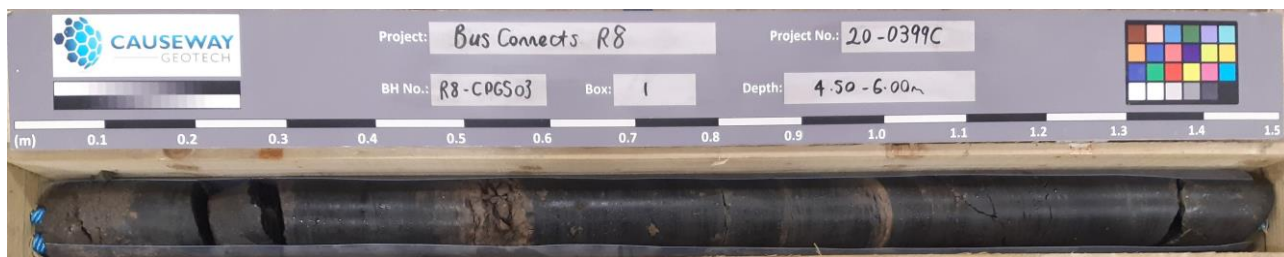
R8-CPGS03 Box 1 4.50-6.00m

4.55	C				42.78	4.30	Grey LIMESTONE. Driller's description)						
4.70	ES				42.58	4.50	Medium strong thickly bedded dark grey LIMESTONE. Partially weathered: slightly reduced strength, slightly closer fracture spacing with localised brown clay deposits.

5.05	C						Discontinuities:						
5.30	C	100 97 72					1. 0 to 15 degree bedding fractures, medium spaced (65/225/480), planar, and slightly undulating, smooth with brown clay infill up to 58mm between some fracture surfaces and orange staining on fracture surfaces.

6.00	C						2. 20 to 40 degree joints, widely spaced (210/1235/1370), undulating, smooth with brown clay infill up to 6mm between some joint surfaces and no staining on joint surfaces.

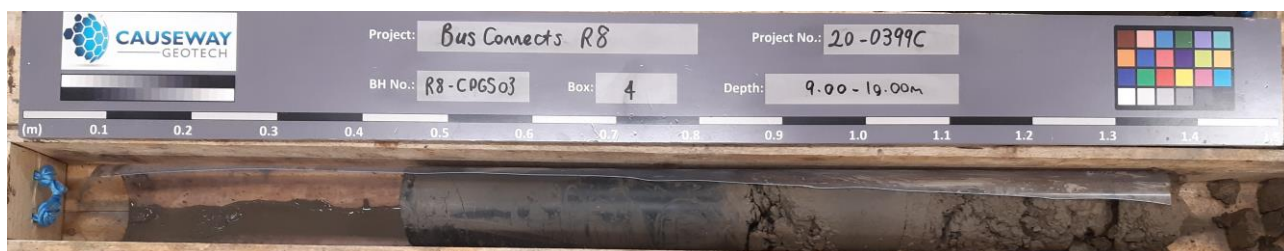
R8-CPGS03 Box 4 9.00-10.00m

Depth (m)	Samples / Field Records	TCR	SCR	RQD	FI	Casing Depth (m)	Water Depth (m)	Level mOD	Depth (m)	Legend	Description	Water	Backfill
10.00		100	57	55	NI			37.43	9.65 (0.35)		Medium strong thickly bedded dark grey LIMESTONE. Partially weathered: slightly reduced strength, slightly closer fracture spacing with localised brown clay deposits. Discontinuities: 1. 0 to 15 degree bedding fractures, medium spaced (65/225/480), planar, and slightly undulating, smooth with brown clay infill up to 58mm between some fracture surfaces and orange staining on fracture surfaces. 2. 20 to 40 degree joints, widely spaced (210/1235/1370), undulating, smooth with brown clay infill up to 6mm between some joint surfaces and no staining on joint surfaces. 3. At 5.85m to 6.00m and 7.95m to 8.15m: 85 to 90 degree joints, undulating, smooth with brown clay deposits on joint surfaces. <u>9.43m to 9.51m: Brown sandy gravelly clay infill.</u> Soft becoming firm brown sandy gravelly CLAY. Sand is fine to coarse. Gravel is subangular fine to coarse of limestone. End of Borehole at 10.00m		9.5

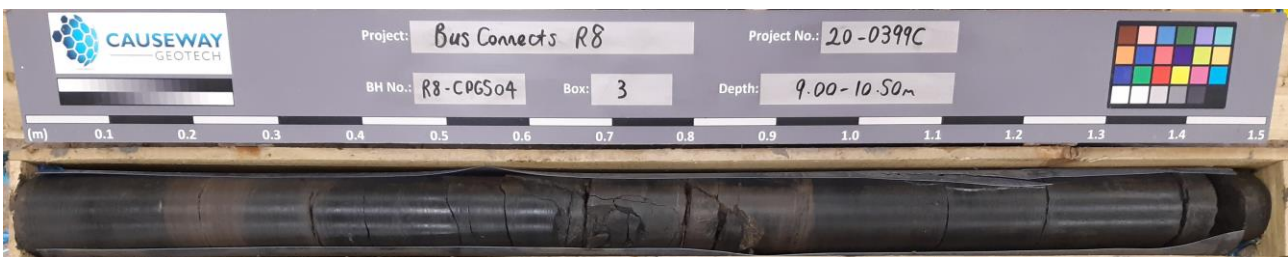
R8-CPGS04 Box 3 9.00-10.50m

Depth (m)	Samples / Field Records	TCR	SCR	RQD	FI	Casing Depth (m)	Water Depth (m)	Level mOD	Depth (m)	Legend	Description	Water	Backfill
10.15	C	100	100	62	>20					<p>Medium strong becoming strong thickly bedded dark grey LIMESTONE. Partially weathered: closer fracture spacing with localised brown clay deposits. Discontinuities: 1. 0 to 10 degree bedding fractures, closely spaced (30/150/400), planar and slightly undulating, smooth with localised brown clay infill up to 7mm between some fracture surfaces. 2. At 8.30m to 8.74m, 9.60m to 9.80m and 10.50m to 10.85m: 75 to 90 degree incipient joints, undulating, rough with localised brown clay infill up to 8mm and no staining on joint surfaces. 3. At 9.80m to 9.90m; 70 degree incipient joint, undulating, smooth with brown staining on joint surface.</p>

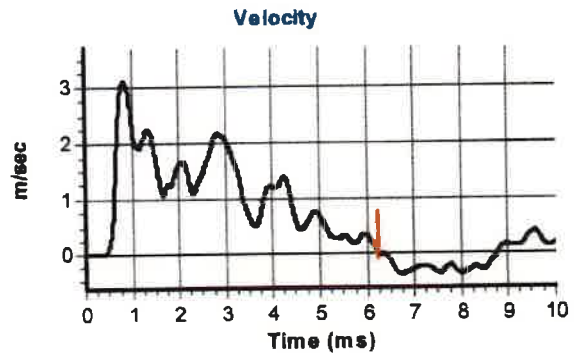
SPT Hammer Ref: .0209  
Test Date: 22/02/2020  
Report Date: 03/03/2020  
File Name: .0209.spt  
Test Operator: NPB

Area of Rod A ( $\text{mm}^2$ ): 905  
Theoretical Energy  $E_{\text{theor}}$  (J): 473  
Measured Energy  $E_{\text{meas}}$  (J): 317

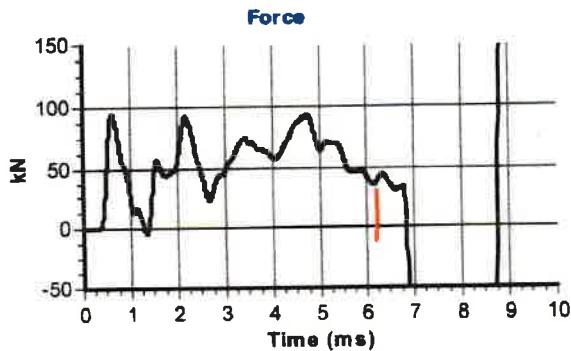
Area of Rod A ( $\text{mm}^2$ ): 905  
Theoretical Energy  $E_{\text{theor}}$  (J): 473  
Measured Energy  $E_{\text{meas}}$  (J): 400
