Appendix VI
Aquatic Baseline Report

Aquatic baseline report for the BusConnects project, Dublin City

Prepared by Triturus Environmental Ltd. for Scott Cawley

December 2020

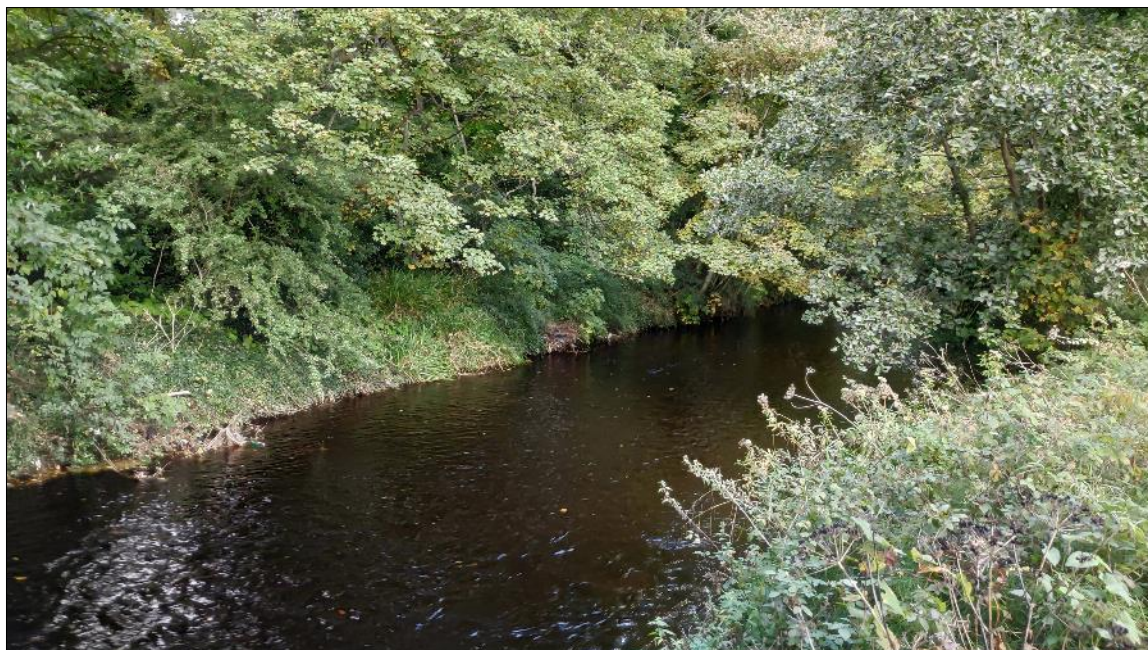
In summary, given the excellent salmonid habitat - in particular spawning gravel, with other areas of good quality nursery and holding habitat observed at this site. Otter activity was not seen at this site during survey, but it is thought that habitat potential at this site was high for this species.

Plate 3.8 Representative image of site D1 on the River Dodder at Rathdown Park

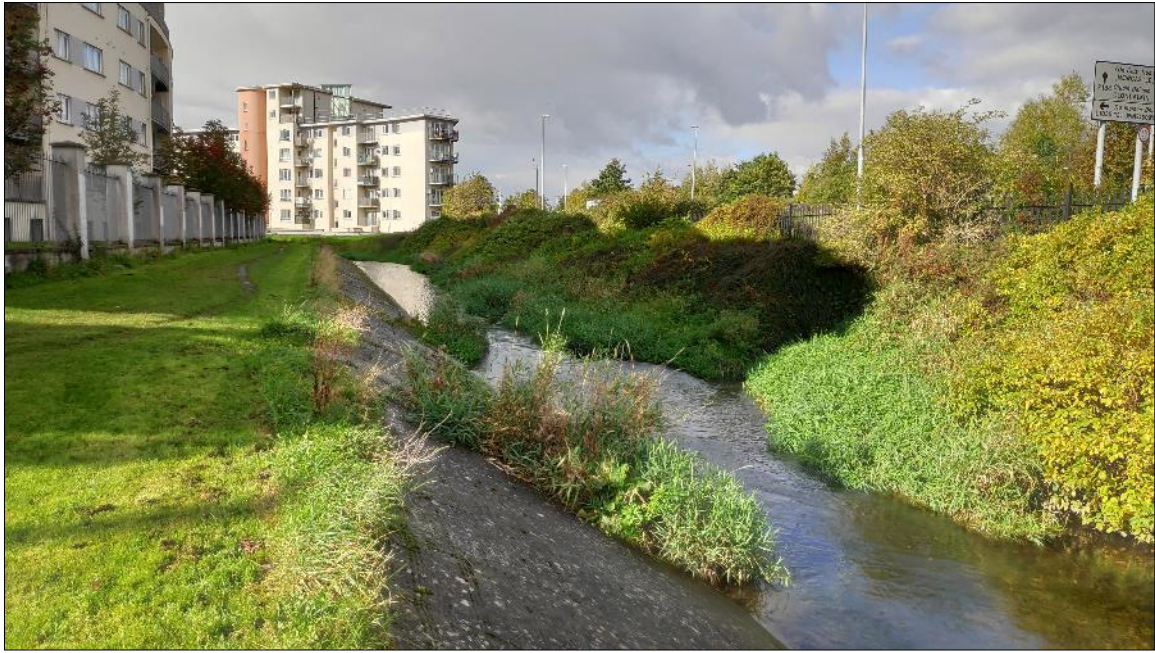
In summary, salmonid habitat was found to be of moderate quality, with moderate quality lamprey habitat and low densities of Annex II white-clawed crayfish at this site.

Plate 3.9 Representative image of site C1 on the River Camac (facing upstream)

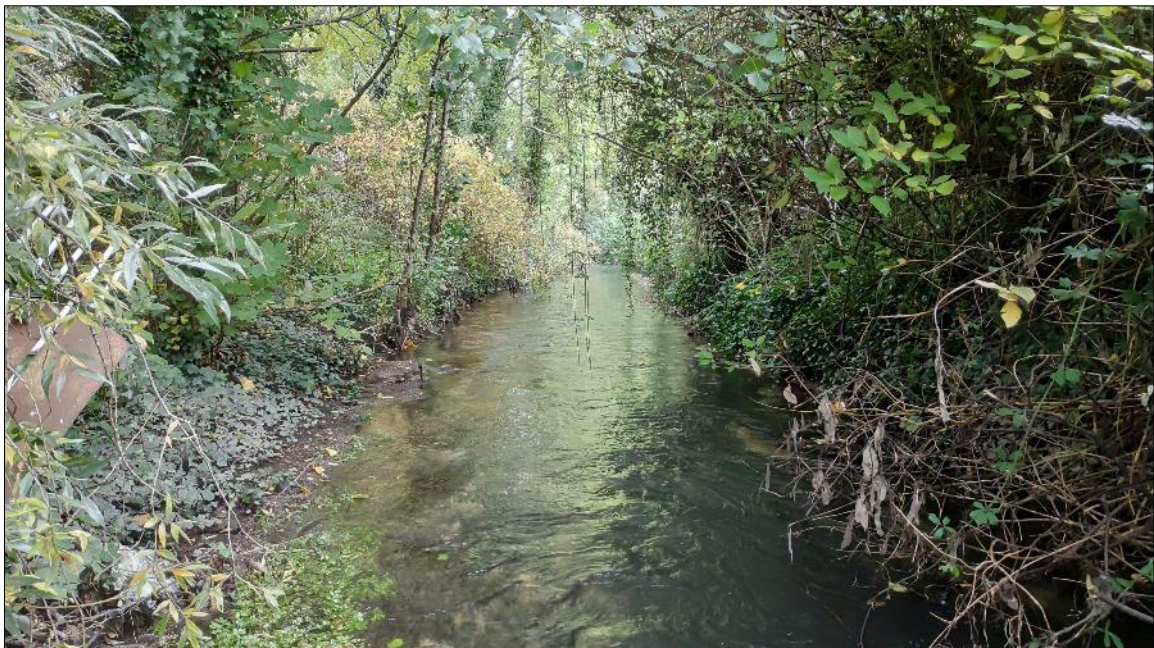
Plate 3.11 Representative image of site C2 on the River Camac (downstream of the culvert)
